PROPER APPLICATION & MAINTENANCE OF MOLDED CASE BREAKERS TO ASSURE SAFE AND RELIABLE OPERATION

Abstract - This paper will discuss the importance of reliable and repeatable performance of molded case circuit breakers in today's power distribution systems. The paper will review existing standards for maintenance of molded case breakers including procedures outlined in NEMA AB4 and IEEE1458. Common misconceptions and system application issues regarding these devices will be discussed. Several examples of on-line infrared scans of circuit breakers over the course of a five year period will be presented and reviewed. Experiences at an integrated paper mill located in Longview, Washington USA explains documented cases where infrared thermography has been used as a predictive maintenance tool in determining potential problems with breakers while in service. Follow-up analysis by the circuit breaker manufacturer has generally validated mill maintenance decisions to remove a breaker from service and replace it, based on infrared scan results. Periodic infrared scanning used as a tool in identifying potential problems with sealed molded case circuit breakers will be discussed. This and othe

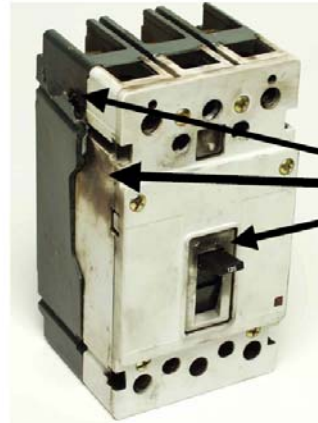
If a circuit breaker with a cracked case or burn marks is found, take the circuit breaker out of service and replace it as soon as safely possible

Fig. 4: Photo from IEEE Standard 1458 showing visible external damage to a breaker case, a stated reason to remove the breaker from service.

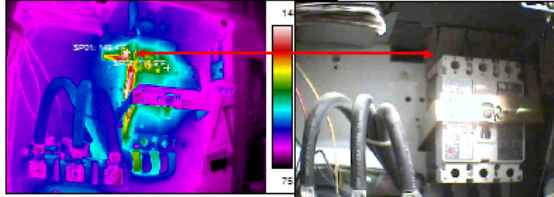
1) *Test Case 1:* The first breaker to be reviewed is a 150 ampere magnetic-only MCCB located in MCC designation D304D-3C. This breaker is identified as Breaker ID 4919-2 (see Appendix A). The MCCB was originally manufactured in 1995, so it had been in service for nearly 13 years. Fig. 7 shows the results from IR scans conducted at the mill site in January 2008. Thermal inspection for this breaker suggested a hot spot temperature of 149.4°F, a temperature above the 130°F threshold temperature identified in the IEEE 1458 Standard (as discussed previously in Section III.C of this text). Note from this thermal image that the observed elevated temperatures resided near the line terminals at the top of the breaker and down the left side. The line terminal connections were checked for tightness, but the temperature issue persisted. Although it was difficult to determine the source of elevated temperatures for the image, with known good terminations the test technician elected to remove this breaker from service and replace it during a scheduled outage.

HOT SPOT	149.4°F
REFERENCE TEMP.	117.9°F
DELTA-T	31.5
MAX RATED AMP LOAD	
ACTUAL AMP LOAD	
COMMENTS	CHECK CONNECTION A-PHASE TOP OF BREAKER
REPAIR / DATE	
REPAIRED BY	
COMMENTS

Fig. 7: Infrared inspection of 150 ampere Breaker 4919-2 located in LV MCC D304D-3C.

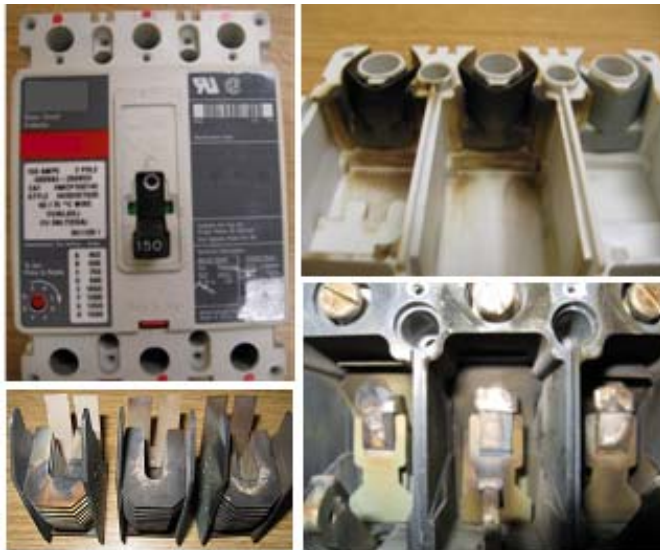
This breaker was then returned to the manufacturer's PIC for analysis. At the PIC, the breaker cover was removed, and each arc-chute assembly was removed from the molded casing. Photos of the breaker external case as well as the inside of the breaker cover, contact area and arc-chute components were taken as shown in Fig. 8. Although there was no visible external damage, some internal components appeared visibly discolored. This evidence suggests that this breaker had interrupted multiple fault currents of a fairly high magnitude. The mill recorded IR thermal hot spot at the upper section of the breaker. This may be significant in that this is in proximity of the MCCB main contacts, suggesting a higher contact resistance, perhaps caused by erosion of the contact surface following interruption of a high-level fault.

Fig. 8: Photos of Breaker 4919-2 clockwise from upper right; external breaker case, line-side of breaker cover, main moving and stationary contacts, arc-chute assemblies.

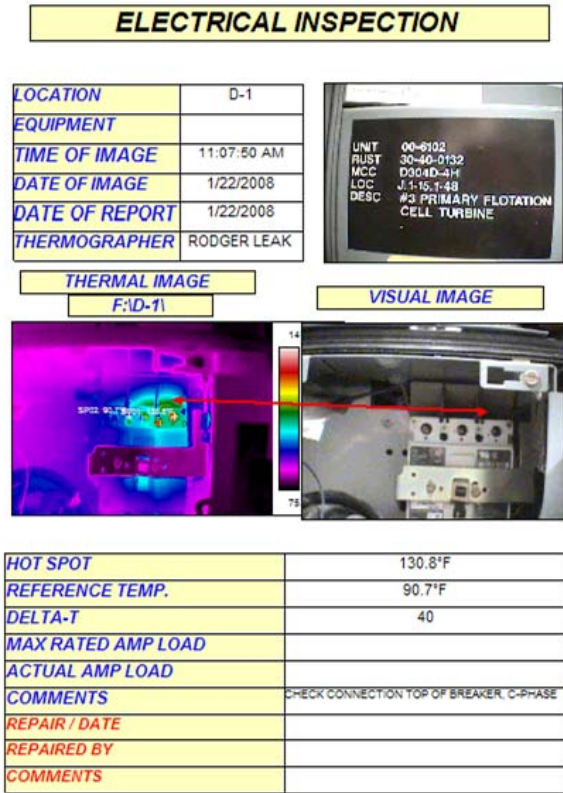
2) *Test Case 2:* The second breaker to be reviewed was also a 150 ampere magnetic-only MCCB located in low-voltage MCC designated D304D-4H. This breaker is identified as Breaker ID 4919-4 with PIC recorded test data shown in Appendix A. Fig. 9 shows the results from IR scans conducted at the mill site in January 2008. Thermal inspection of this breaker suggested a hot spot temperature of 130.8°F. This temperature is just above the 130°F threshold identified in the IEEE 1458 Standard. Once again, from the thermal image the thermal hot spot temperatures appear to be at or near the line terminals of the MCCB. After cable terminations were checked for tightness, this breaker was also removed from service during a rotational outage, again suspected of possible internal damage. This breaker was returned to the manufacturer's PIC, then disassembled and photographs were again taken as shown in Fig. 10. In contrast to the photos for breaker 4919-2 shown in Fig. 8, the photos of this breaker appear to show very little visible wear or burning, evidence of interruption of higher-level faults. The contact surfaces appear only slightly discolored, particularly for phase B and C poles. The arc-chute assemblies look nearly new, although once again, this breaker had a service life of nearly 13 years, with a manufacturing date of November 1995.

The PIC lab thermal test stabilized in 3 hours, 10 minutes when the test was considered complete. Table III shows results from this test. In this case, five out of six of these tested values highlighted in Table III exceed the thermal design threshold of 50°C, with line terminals B and C

demonstrating the highest measured temperatures, a result verified by field based IR scans. Overall, the lab test once again delivered results consistent with IR scans from the field.

Fig. 9: Infrared inspection of 150 ampere Breaker 4919-4 located in LV MCC D304D-4H. Note elevated temperature at line side of MCCB poles B and C.

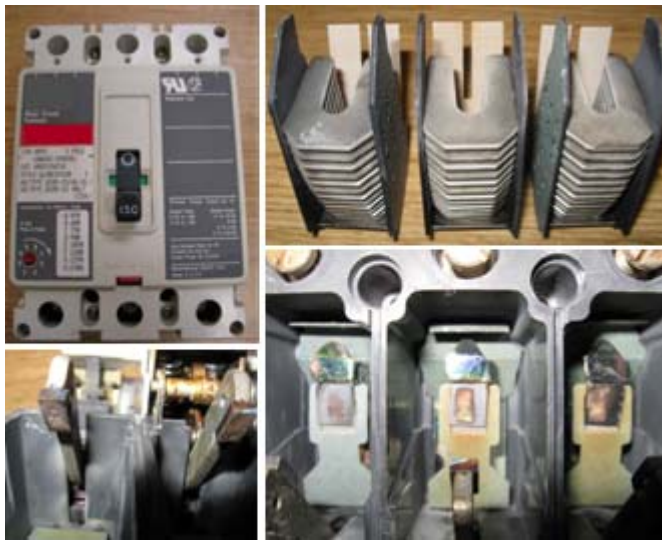
Interestingly, there was a significant disparity between phase terminal temperatures, but with less visible discoloration from the photographs in Fig. 10.

Fig. 10: Photos of Breaker 4919-4 clockwise from upper right; external breaker case, arc-chute assemblies, main moving and stationary contacts with evidence of elevated heat primarily on Phases B and C, close-up of Phase C moving contact.

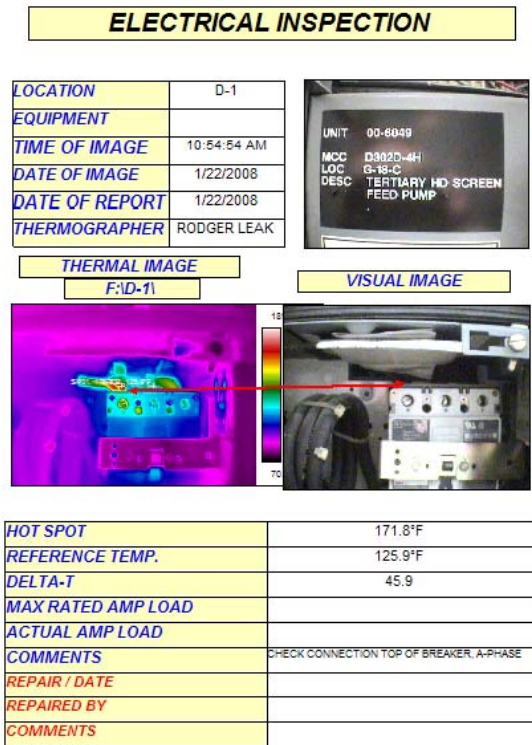
3) Test Case 3: The third breaker to be reviewed is also a 150 ampere magnetic-only MCCB; this one located in low-voltage MCC designated D302D-4H. This breaker is identified as Breaker ID 4919-1 with PIC recorded test data shown in Appendix A. Fig. 11 shows the results from IR scans conducted at the mill site in January 2008. Thermal inspection for this breaker suggested a hot spot temperature of 171.8°F. This temperature is well above the 130°F IEEE 1458 Standard threshold. Once again, from the thermal image the hot spot temperatures appear to be at or near the line terminals of the MCCB. After cable terminations were checked for tightness, this breaker was also removed from service during a rotational outage.

Fig. 11: Infrared inspection of 150 ampere Breaker 4919-1 located in LV MCC D302D-4H. Note elevated temperature at line side of MCCB with hot spot temperature of 171.8°F.

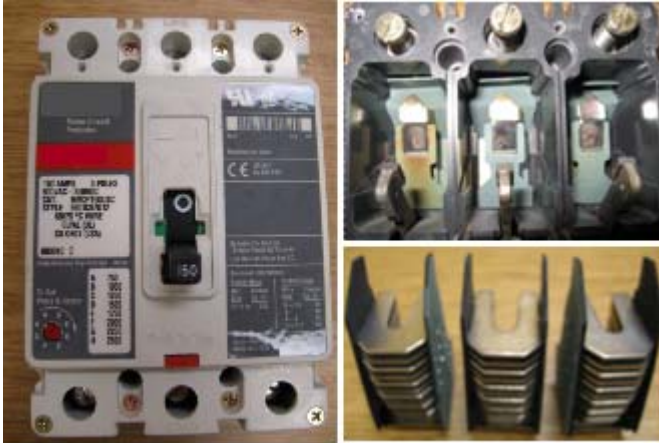
This breaker was also returned to the manufacturer's PIC where it was disassembled. Photographs are shown in Fig. 12. Similar to the previous example of Breaker 4919-4, the internal components of this MCCB appear to show very little visible wear or burning. The contact surfaces appear only slightly discolored, particularly for the Phase A breaker pole. This breaker was manufactured in December 1999, so the MCCB was in service for just over 8 years.

Fig. 12: Photos of Breaker 4919-1 clockwise from upper right; external breaker case, main moving and stationary contacts, arc-chute assemblies.

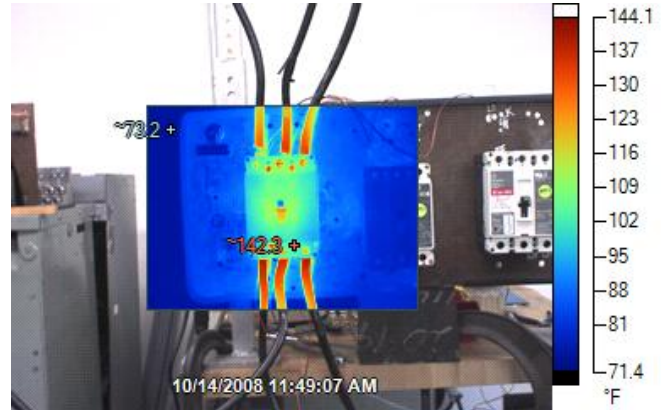
It's instructional here to note that the thermal test lab at the PIC also included a thermal image test using thermography similar to the field based IR scans. Fig. 13 shows the test lab thermal image for Breaker 4919-1. Comparing this image to the field IR scan shown in Fig. 11, the hot spot temperature was recorded at 142.3°F, a value much lower than the 171.8°F hot spot temperature measured by the mill. This suggests that perhaps some variable in the field such as an unbalanced load or a line terminal that in fact was improperly tightened, caused an overall higher hot spot temperature. It is also interesting to compare the field and test lab overall thermal images of this breaker. Note that the thermal profile of the lab test appears more consistent throughout the MCCB

frame, whereas the field IR scan shows a more isolated area of elevated temperature. Remember that the IR camera is recording surface temperature. IR is not measuring the actual heat generated by the conducting components of the breaker, but instead the camera measures the deflected and absorbed temperature of the conductors through the breaker frame. The lab test condition represents a balanced 3-phase 150 ampere current, while the field test condition presents infinitely more variables. So, some variability is to be expected.

Fig. 13: PIC thermal scan of breaker 4919-1. Breaker tested at 150 ampere rated load for 4 hours, 35 minutes, 142.3°F hot spot.

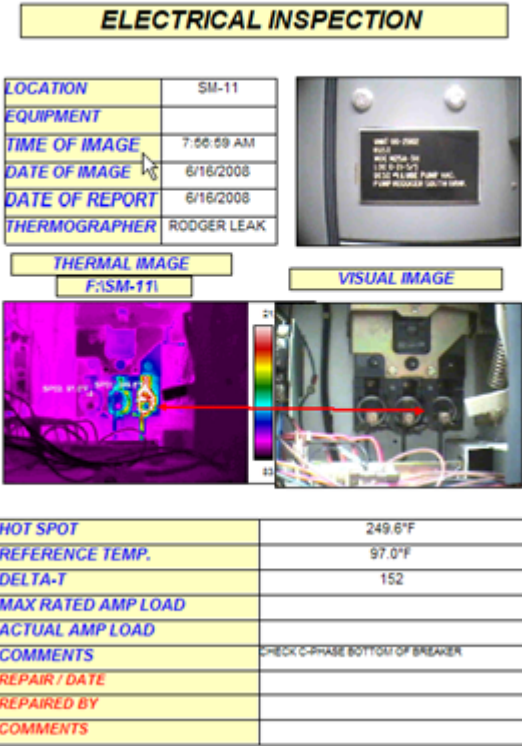
The current limiter looks to be another good candidate for routine IR surveys as a means to attempt to determine when an overcurrent protective device may not be capable of interruption as designed, and therefore should be removed from service and replaced.

Fig. 14: Thermal scan of partially failed current-limiter installed in Paper machine #1 area. Elevated hot spot temperatures of nearly 250°F resulted in a decision to remove this device from service.

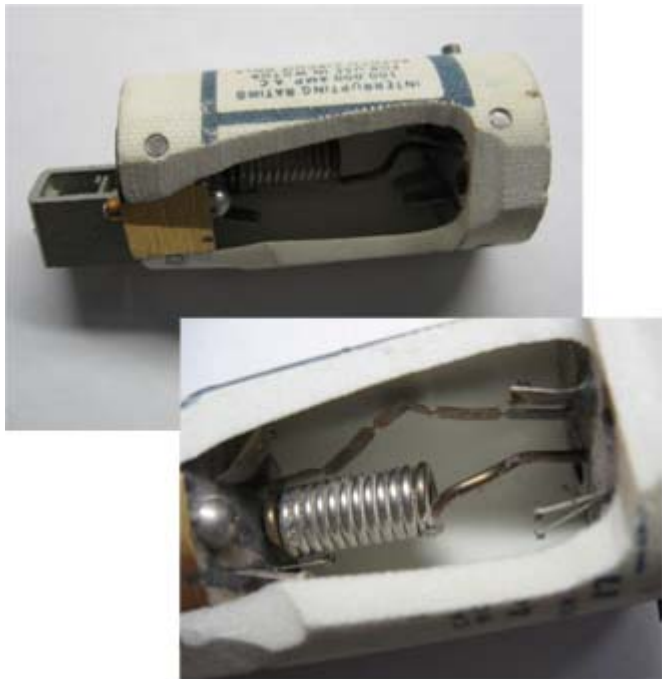
Fig. 15: Photo of current-limiter removed from service from Paper Machine #1 area. Cutaway view shows three elements melted while one remains intact.
