BACKED BY
Roadranger
SUPPORT

Subject: Heavy Duty Clutch May Not Achieve Full Departure – Mechanical and Automated

Document Number: CLIB-0035

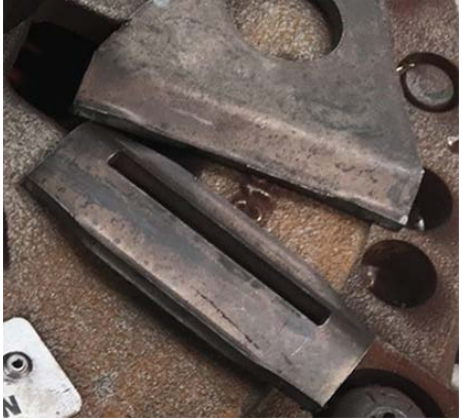
Customers may experience various fault codes and/or clutch release complaints due to broken clutch levers in self-adjust clutches used with automated and manual transmissions. Figures 1-3 below illustrate a failed clutch lever.

Figure 1: Broken Lever Pieces	Figure 2: Broken Lever found in Clutch Housing	Figure 3: Broken Lever found in Cover Assembly

Service Option	Description
1.	<p>If a vehicle is at a repair facility for any transmission or clutch related issue that requires transmission removal, request and record the installed clutch part number and serial number.</p> <ul style="list-style-type: none"> • If the clutch serial number is between the Start and End indicated below, the repair facility is to replace the clutch: <ul style="list-style-type: none"> ○ Start: AU1704010001 / SL1704010001 – 17(Year) 04(Month) 01(Day) ○ End: AU1806139999 / SL1806209999 – 18(Year) 06(Month) 01 or 05(Day). • Replace clutch using the standard warranty process.

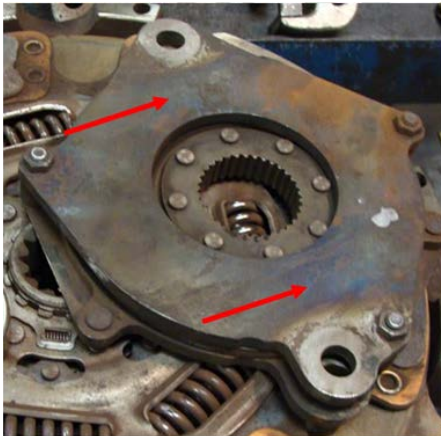
- ECA Clutch Kit Part Number – 122002-35EX (1850 ft-lbs) or 122003-42 (2250 ft-lbs) minus LCIB should be utilized. Inspect LCIB for excessive heat, if heat is present use 122002-35A or 122003-42A, see Figure 4.

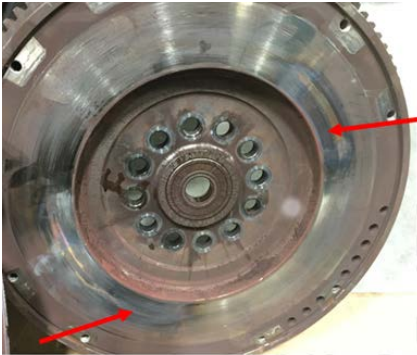
Figure 5.

- Parts outside of the above listed are not covered under this document. Example: oil pan gaskets, engine mounts, release bearing/cross shaft grease tubes, crank sensor, or u-joints.
- One 1 u-joint strap kit will be covered.
- Pilot Bearings will be covered. Replace with OEM recommended pilot bearing or Reference CLTS1271 for recommended pilot bearings. Maximum reimbursement is \$50 USD.
- Gaskets related to exhaust and PTO removal/installation will be covered.
- If hot spots are identified (Figure 5), Flywheel resurfacing will be covered up to a maximum \$130 USD charge.

Note: If flywheel is replaced due to progressive damage beyond machining tolerances pictures of both front and back of flywheel must be attached to claim
