A Case Study of Voltage Transformer Failures

SOLUTION IMPLEMENTATION IN A MODERN DATA CENTER

By Tamer Abdelazim Mellik,
Thomas J. Dionise, and
Robert Yanniello

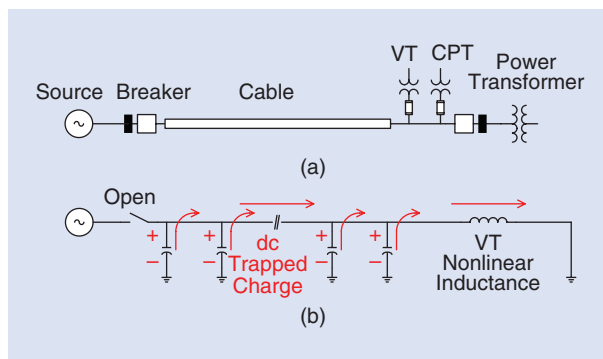
FIGURE 1. A conceptual explanation of VT ferroresonance: (a) a one-line diagram and (b) circuit parameters influencing ferroresonance. VT: voltage transformer; CPT: control power transformer.

An equally important problem is ferroresonance. ANSI/IEEE Standard 100-1984 [8] defines ferroresonance as “a phenomenon usually characterized by overvoltages and very irregular wave shapes and associated with the excitation of one or more saturable inductors through a capacitance in series with the inductor.” The key elements are saturable inductors in series with capacitance, as shown in Figure 1. In the ferroresonant circuit, the capacitance (XC) can be the capacitance of cable, overhead lines, or stray capacitance of transformer windings or bushings. Under normal operation, XC is smaller than the inductive reactance (XL). However, if some switching event causes the voltage to increase, then the transformer core may be pushed into saturation and the XL lowered. It is possible at some higher voltage that this lower saturated value of XL may equal XC, forming the series resonant circuit called ferroresonance [9]. The ferroresonance phenomenon, as it relates to a VT, is explained in detail in [3].

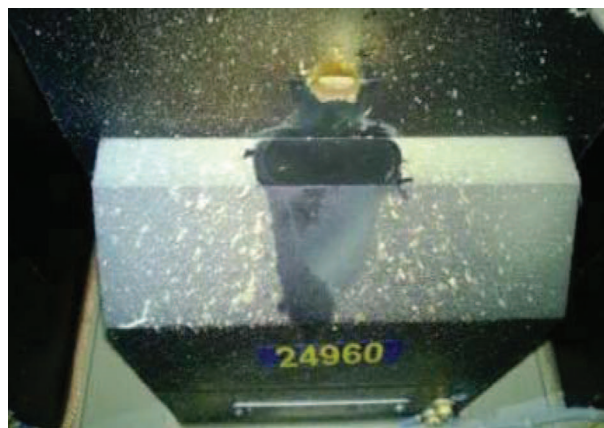
On 18 November 2013, this data center experienced the failure of two line-end VTs at 24.9 kV in newly installed switchgear. The damage to the line-end VT is shown in Figures 2 and 3. During the investigation, the

FIGURE 2. A line-end VT failure.

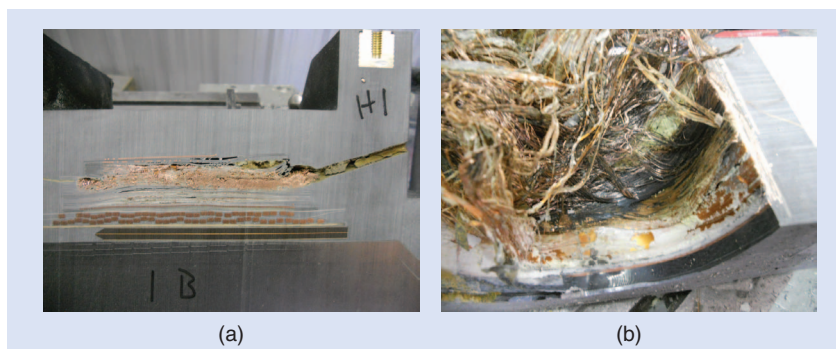
FIGURE 3. A cross section of the line-end VT failure: (a) the VT high-voltage side and (b) the VT windings.

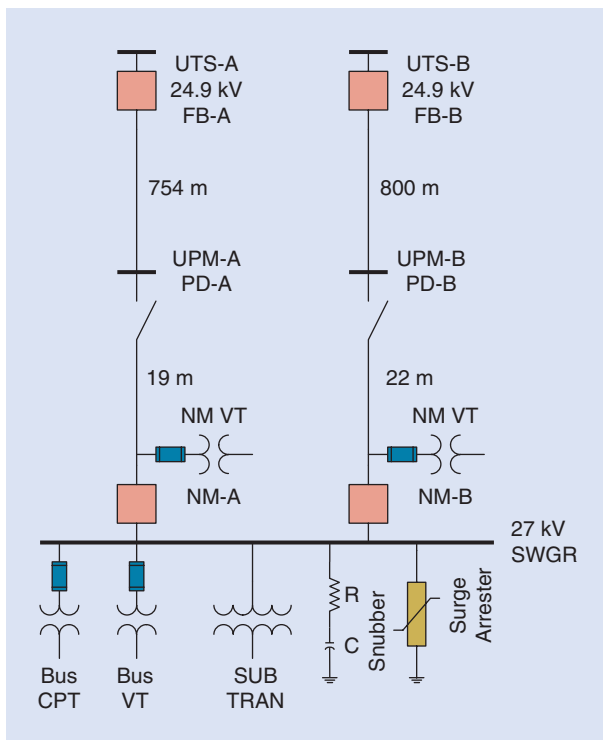
FIGURE 4. A simplified one-line diagram of a typical cell at the data center. R: resistor; C: capacitance; SWGR: switchgear; SUB TRAN: substation transformer; PD: pad-mounted switch.

We conducted a comprehensive investigation of the VT failures by modeling the data center power distribution system, including the switchgear and VTs online and bus-side of the switchgear lineups, and performing a switching transient study to quantify the transient overvoltage produced by the 27-kV breakers at the UTS unit substations.

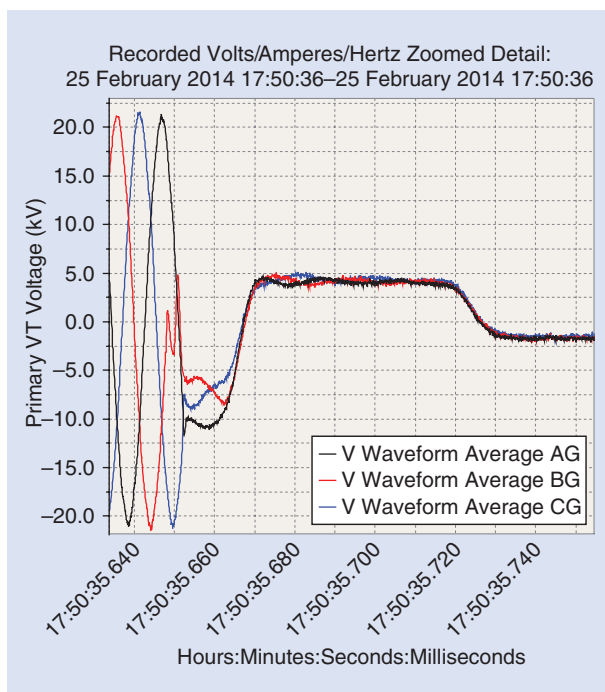
During this scenario, a 5-kV square wave at 5–20 Hz was measured during baseline testing. This is very typical of most breaker opening cases, as seen on the bus VT primary shown in Figure 5. Similar results occur when any upstream 27-kV breaker is opened. This is the low-frequency form of ferroresonance associated with VT saturation. The simulation illustrated the worst condition occurred by opening the 27-kV breaker FB-B in switchgear UTS-B with a cable length of 800 m. This case, shown in Figure 6, represents the existing system condition and is the most severe, with the breaker opening time chosen at the phase B maximum voltage. Figures 5 and 6 show a saturation form of ferroresonance, with 5–10-peak kV (kV_{pk}) square waves and an estimated frequency of 17 Hz. The magnitude is well below the normal peak value of 20 kV_{pk} . However, it appears the square wave persists.

FIGURE 5. The bus VT primary average. AG: phase A to ground; BG: phase B to ground; CG: phase C to ground.

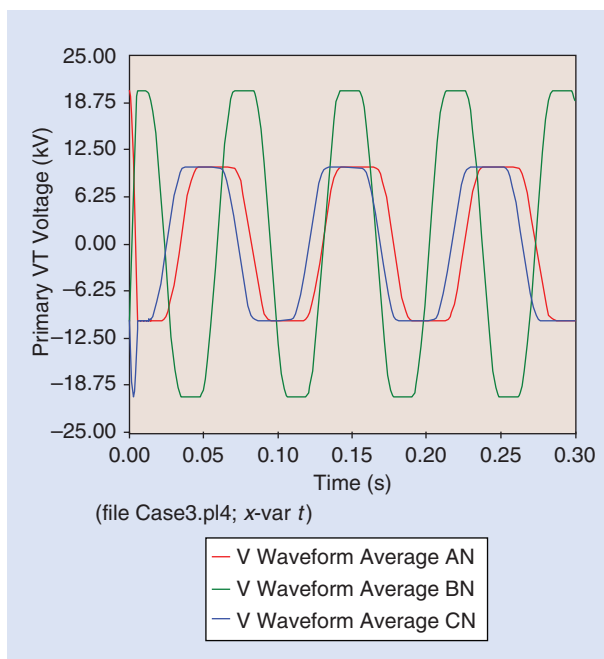
Another example of the saturation form of ferroresonance of 5–10 Hz is shown for the UTS breaker FB-A opening during baseline testing, as seen on the bus VT secondary in Figure 7. The simulation illustrates that the worst condition occurs by opening the 27-kV-breaker FB-B in switchgear UTS-B with a cable length of 800 m. This case, shown in Figure 8, represents the existing system condition and shows the VT secondary voltage, the more severe case with the breaker opening time chosen

FIGURE 6. The primary line-to-ground voltage after the breaker is opened, illustrating ferroresonance on phase B (from simulation). AN: phase A to neutral; BN: phase B to neutral; CN: phase C to neutral.

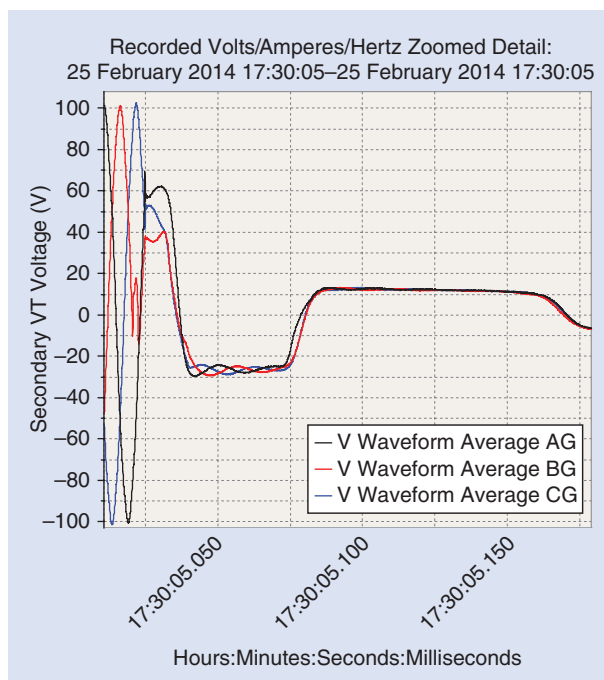
at the phase B maximum voltage. Figures 7 and 8 show a saturation form of ferroresonance, with a 10–30- V_{pk} square wave and an estimated frequency of 5–10 Hz. The magnitude is well below the normal peak value of 100 V_{pk} .

FIGURE 7. The bus VT secondary. AG: phase A to ground; BG: phase B to ground; CG: phase C to ground.

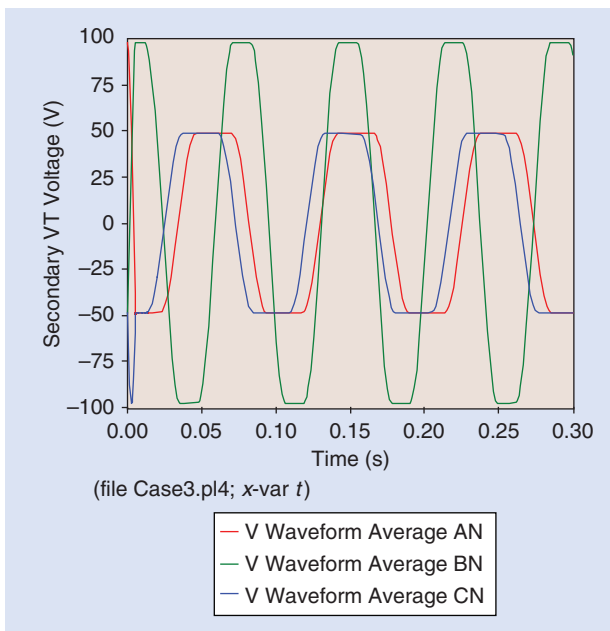
FIGURE 8. The VT secondary voltage after the breaker opens; the ferroresonance is demonstrated from simulation. AN: phase A to neutral; BN: phase B to neutral; CN: phase C to neutral.

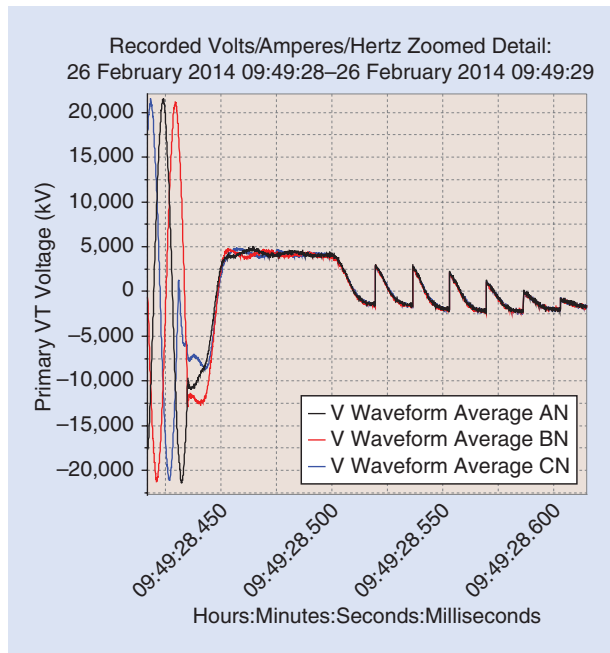
Another example of the saturation form of ferroresonance, during UTS breaker opening, is shown in Figure 9, a saturation 5-kV square wave followed by a sawtooth with six peaks. The figure shows a saturation form of ferroresonance with a 5-k V_{pk} square wave. The sawtooth indicates the line-to-ground voltage coupled through the voltage dividers. The magnitude is well below the normal peak of 20 k V_{pk} .

FIGURE 9. The NM-A VT primary, from transients. AN: phase A to neutral; BN: phase B to neutral; CN: phase C to neutral.

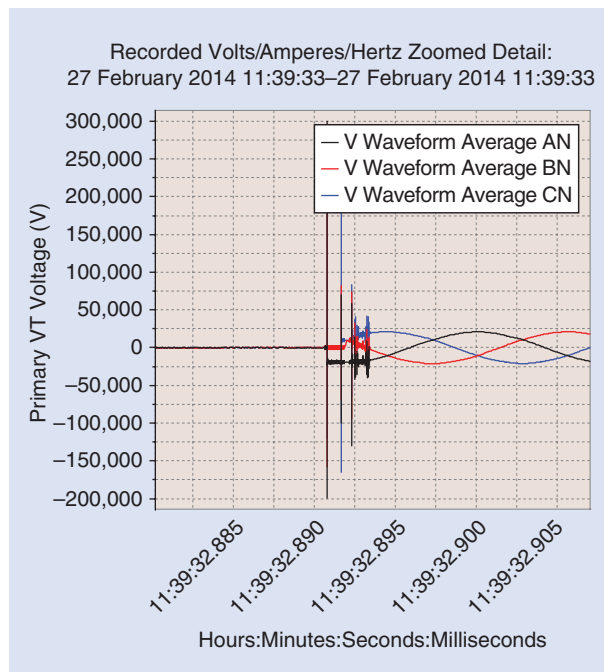
During the UPM switch closing, a prestrike was captured on the NM-B VT primary transients, as shown in Figure 10. The prestrike shown during breaker closing on all three phases exhibited the highest magnitude, 300 k V_{pk} , at phase C. The prestrike at phase B was a magnitude of 440 k V_{pk} . This is the line-to-ground voltage coupled through the voltage dividers.

FIGURE 10. The NM-B VT primary, from UPM transients. AN: phase A to neutral; BN: phase B to neutral; CN: phase C to neutral.

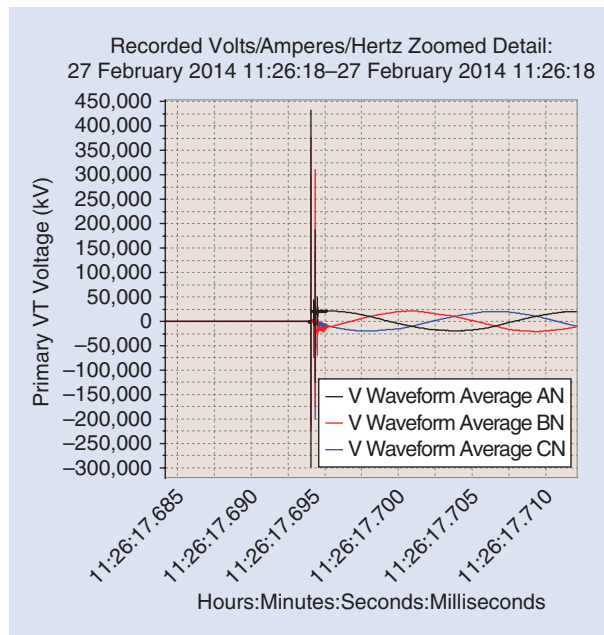
During UPM switch closing, a prestrike was captured as seen on the bus VT primary transients (Figure 11). The prestrike occurred during the breaker closing on all three phases; the highest magnitude was 435 k V_{pk} . The prestrike at phase B had a magnitude of 305 k V_{pk} , and the one at phase C had a magnitude of 190 k V_{pk} .

FIGURE 11. The bus VT primary, from baseline testing. AN: phase A to neutral; BN: phase B to neutral; CN: phase C to neutral.

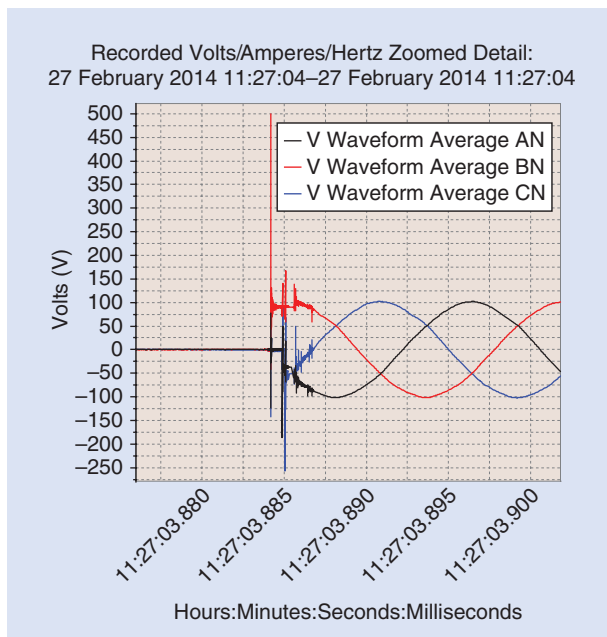
During the UPM switch closing, a prestrike was captured, as seen on the NM-A VT secondary (Figure 12). The prestrike occurred during the switch closing on all

three phases, with the highest magnitude being 500 V_{pk} at phase A. The prestrike at phase C had a magnitude of 135 V_{pk} , and the one at phase B had a magnitude of 260 V_{pk} . This is the line-to-ground voltage capacitively coupled from the primary to the secondary of the VT.

FIGURE 12. The UPM VT secondary, from UPM transients. AN: phase A to neutral; BN: phase B to neutral; CN: phase C to neutral.

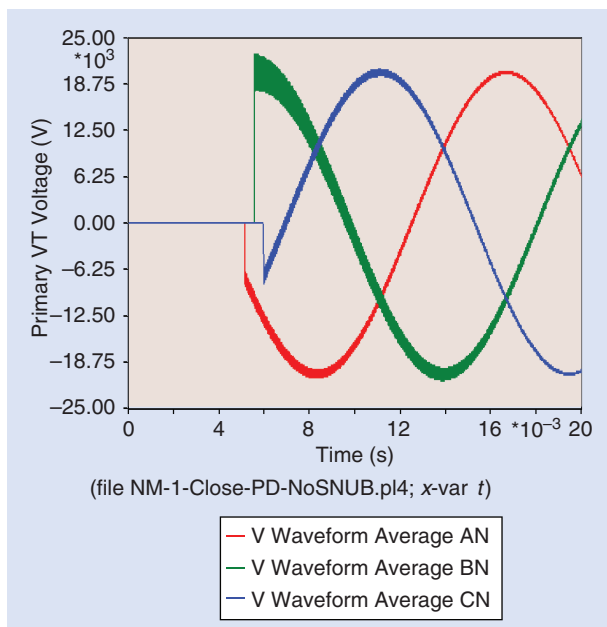
with a cable length of 19 m and a pole disagreement of 0.4 ms. Similar to the UPM transient testing, no load was connected at the VT secondary (existing system configuration). Figure 13 shows the line-to-ground TOV is 22.91 kV, with a frequency of 33 kHz. A similar waveform was captured during the energization of a feeder with the NM breaker open. This was typical of all transients observed during the testing, as shown in Figures 14 and 15.

FIGURE 13. The primary line-to-ground voltage after the switch is closed (from simulation). AN: phase A to neutral; BN: phase B to neutral; CN: phase C to neutral.

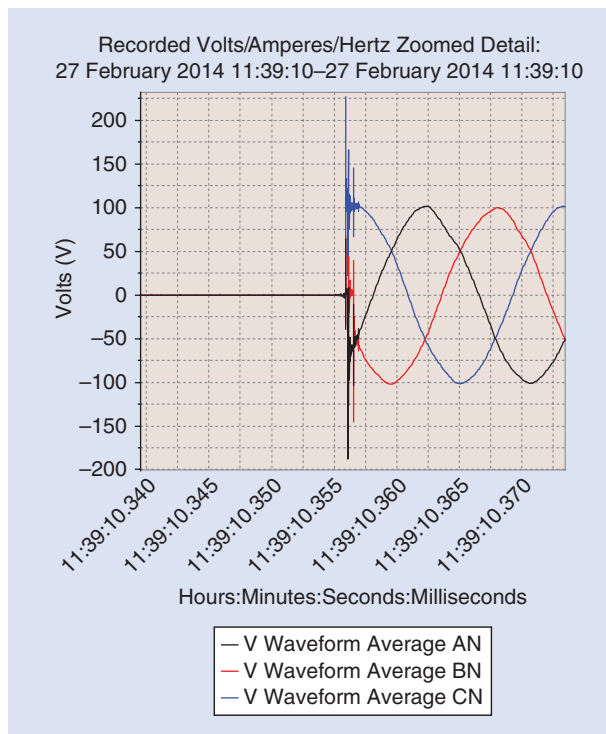
FIGURE 14. The bus VT secondary, from UPM transients. AN: phase A to neutral; BN: phase B to neutral; CN: phase C to neutral.

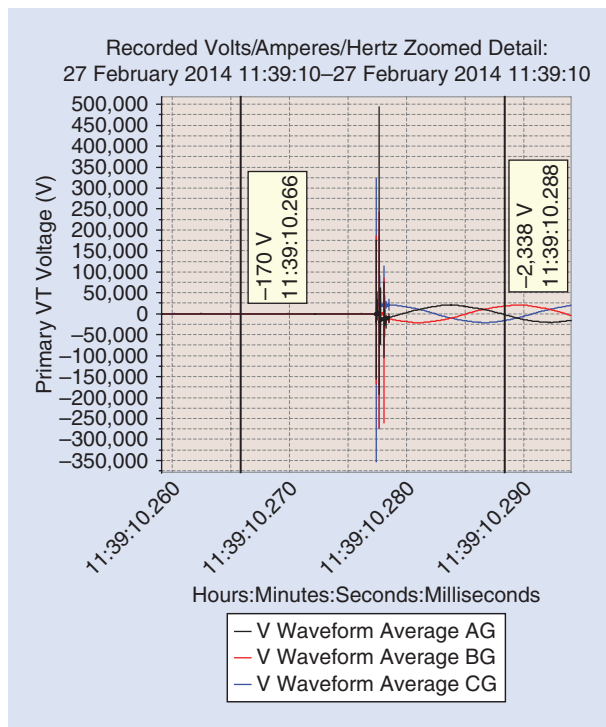
FIGURE 15. A similar scenario to Figure 14, but with a higher voltage transient. AG: phase A to ground; BG: phase B to ground; CG: phase C to ground.

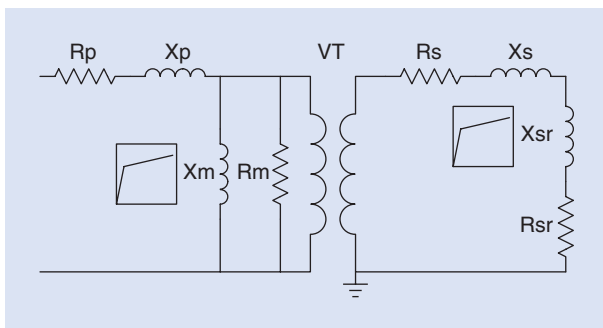
FIGURE 16. The proposed saturable reactor for mitigating VT ferroresonance.

The proposed and effective solution for mitigating the ferroresonance is a saturable reactor, as shown in Figure 16. After the upstream circuit breaker opens, there will be a dc trapped voltage on the open line. With the VT online side of the downstream breaker, the trapped voltage can be large enough to saturate the VT magnetizing impedance, setting up a resonance condition, which causes the current to oscillate as a square wave. The oscillation can last for an extended period of time, until the eventual failure of the VT. The failure may not necessarily occur based upon just one switching event but can occur over time based upon a number of switching events and where the circuit breaker opens on the voltage waveform [3].

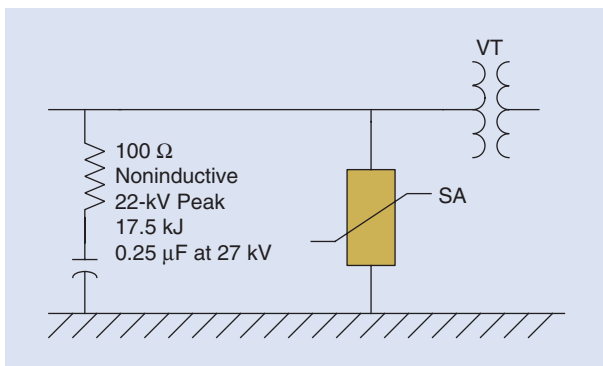
FIGURE 17. The snubber solution for mitigating transient overvoltage at the VT. SA: surge arrester.

Modeling and site measurements have shown that VCB-induced voltage transients can cause damage to the bus and line VTs because of the short cable lengths. The results of the study indicated that one snubber on the line side of each VT would dramatically reduce the magnitude of the voltage transient as well as its dc offset. The snubber was shown to reduce the frequency of the transient oscillation below the recommended 1,000 Hz. The snubbers were sized per IEEE Standard C57.142-2010 [2], [15]–[17], as shown in Figure 17.

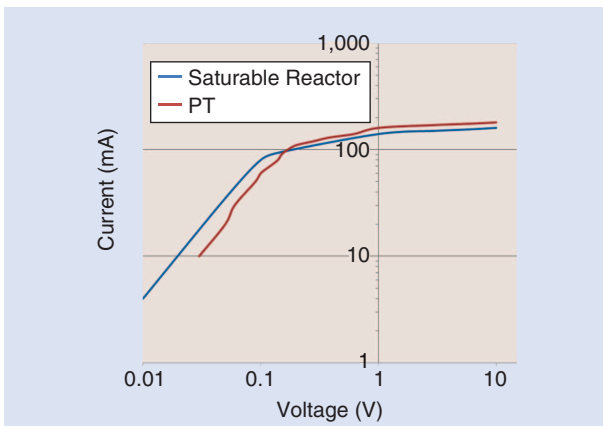
FIGURE 18. A custom saturable reactor designed to mitigate ferroresonance.

For mitigating the ferroresonance, a custom saturable reactor was created based on the VT saturation curve, as shown in Figure 18. The saturable reactor should be designed to saturate above the VT it is protecting; otherwise it creates a high impedance load on the VT. When the VT sees an overvoltage that goes beyond its thermal rating, which was around 125% of the rated voltage, then the reactor kicks in—but not before. During site testing, the initial reactor design was saturating before the VT. To shift the curve to the right of the VT’s saturation curve, an air gap of about 0.020 cm/in was added. This technique is incorporated in many CTs used

The air gap shifted the curve about a decade to the right, which is what was needed from the basic design. It also changed the slope of the linear portion of the curve, which has no bearing on its performance. By adjusting the core size and area as well as the number of turns, no dc component can pass through the VT secondary circuit. The coil resistance was increased by reducing the secondary winding copper area to yield 1Ω . By adding a bifilar winding, an added 5Ω was achieved, but this had zero net effect on flux, inductance, and voltage in the reactor winding. This winding was in series with the main coil to give a net resistance of 6Ω .

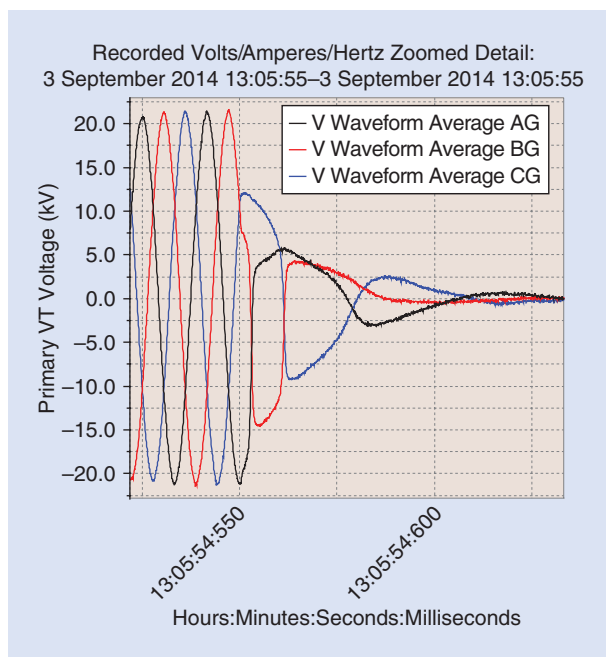
FIGURE 19. The NM-A incoming feeder UTS opening. AG: phase A to ground; BG: phase B to ground; CG: phase C to ground.

As shown in Figure 19, the saturable reactor VT load quickly dampens the ferroresonance to an acceptable level. The simulation results in Figure 20 show similarities to the measured results in Figure 21, and although the simulation case was performed on the most severe case (opening breaker time at the phase B maximum voltage), both cases show damping of

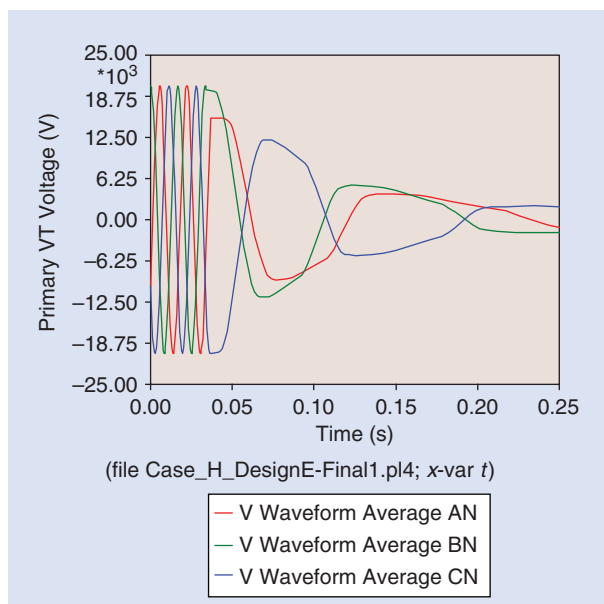
FIGURE 20. The NM-A incoming feeder UTS opening (from simulation). AN: phase A to neutral; BN: phase B to neutral; CN: phase C to neutral.

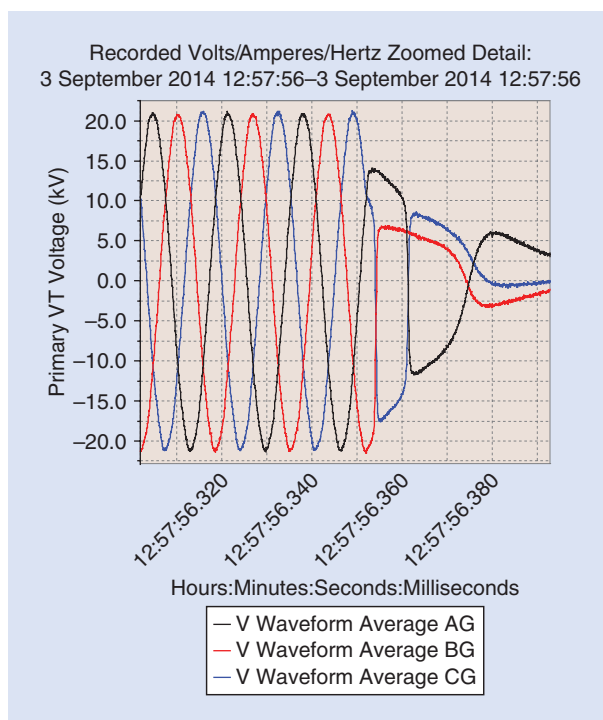
FIGURE 21. The NM-B primary switchgear voltage. AG: phase A to ground; BG: phase B to ground; CG: phase C to ground.

ferroresonance in lower than 250 ms with the saturable reactor installed. This shows the effectiveness of the saturable reactor. Similar waveforms are shown in Figures 21 and 22 for the same switching event of opening the upstream UTS breaker. As shown in Figures 20–22, the damping time is lower than 100 ms, and the voltage magnitude is in the normal peak value of 20 kV.

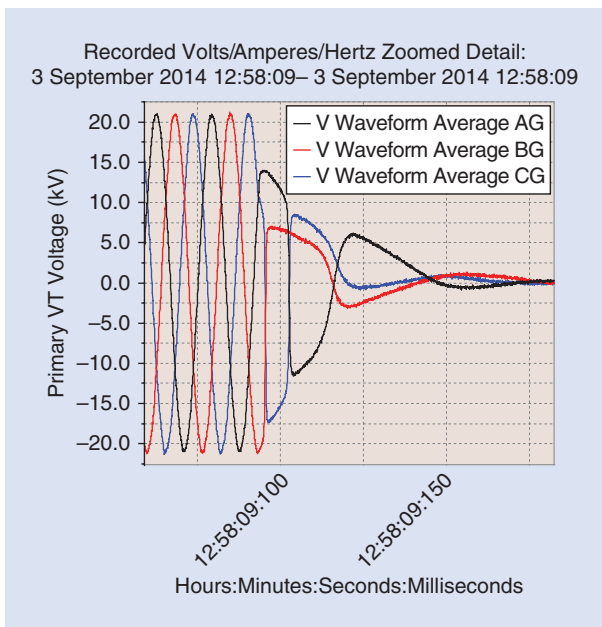
FIGURE 22. The bus primary voltage after UTS opening. AG: phase A to ground; BG: phase B to ground; CG: phase C to ground.

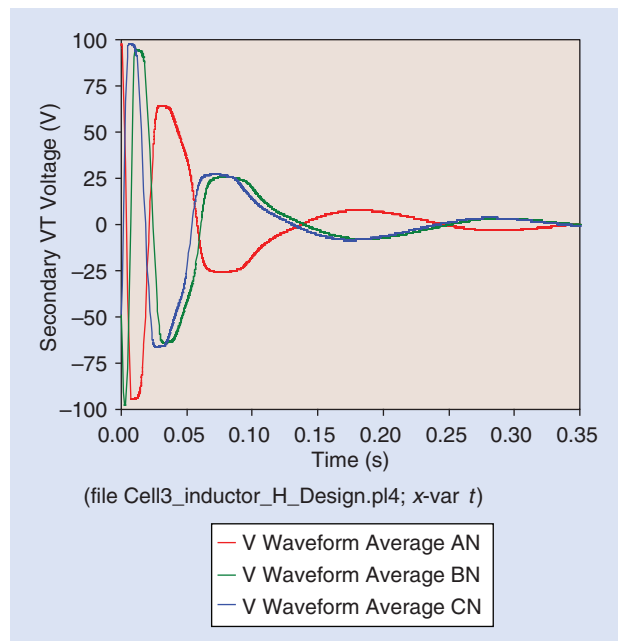
FIGURE 24. The NM-A secondary voltage after UTS opening (from simulation). AN: phase A to neutral; BN: phase B to neutral; CN: phase C to neutral.

In Figures 23 and 24, after opening breaker FB-A, secondary VT waveforms are shown. Figure 23 shows the NM-A secondary voltage, and Figure 24 shows the simulated VT secondary voltage. The simulated case shows the worst case, but both show damping in fewer than 250 ms.

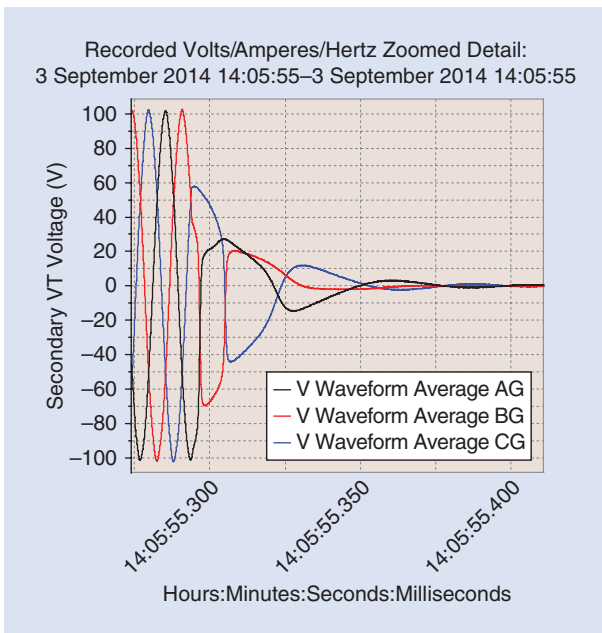
FIGURE 23. The NM-A secondary voltage after UTS opening. AG: phase A to ground; BG: phase B to ground; CG: phase C to ground.

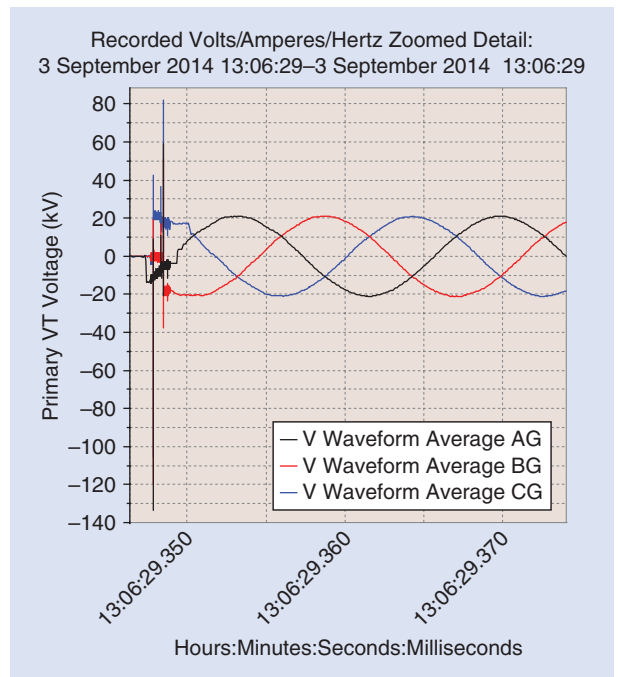
FIGURE 25. The NM-A primary VT voltage. AG: phase A to ground; BG: phase B to ground; CG: phase C to ground.

at the primary of the VTs. During closing, as performed in the “Existing System Conditions (Baseline)” section (closing the UPM switch PD-A upstream), prestrike was captured as seen on NM-A and NM-B VT primaries and in Figures 25 and 26; these figures also show that the TOV was damped quickly after closing the upstream switch and that the voltage magnitude is in the normal peak value of 140 kV.

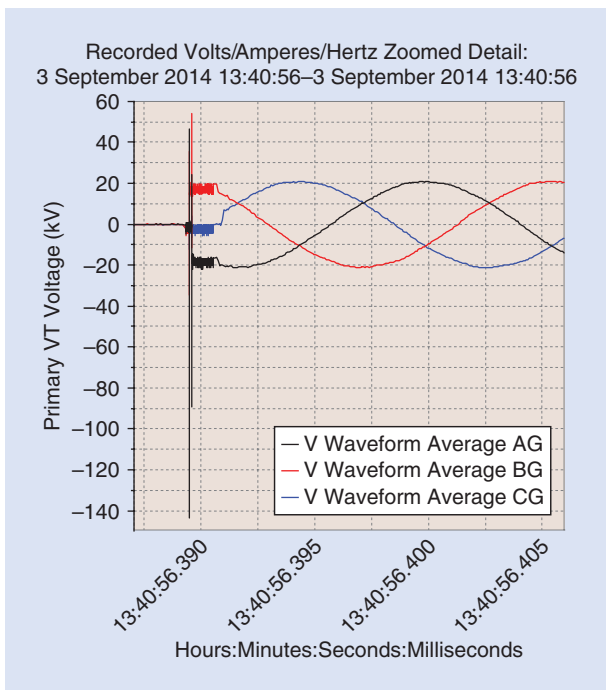
FIGURE 26. The NM-B primary voltage. AG: phase A to ground; BG: phase B to ground; CG: phase C to ground.

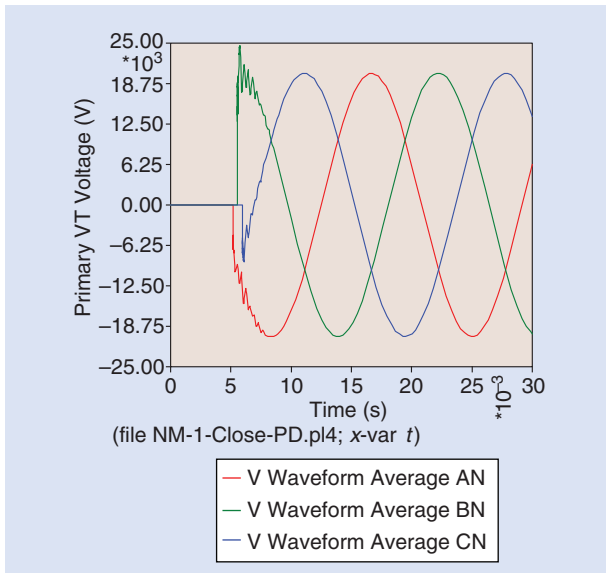
FIGURE 27. The NM-A primary VT voltage after closing the UPM switch using a snubber (from simulation). AN: phase A to neutral; BN: phase B to neutral; CN: phase C to neutral.

This case was again simulated by closing the upstream UPM switch PD-A. The TOV magnitude was 24.67 kV, with a frequency of 3,300 Hz, as shown in Figure 27. Note that the case was initially simulated in EMTF with a 30-Ω resistor and 0.125 μF capacitor. The case was repeated using a fine-tuned snubber (100 Ω and 0.25 μF). This showed a reduced TOV of 26.14 kV, with a frequency of 2,500 Hz, as shown in Figure 28.

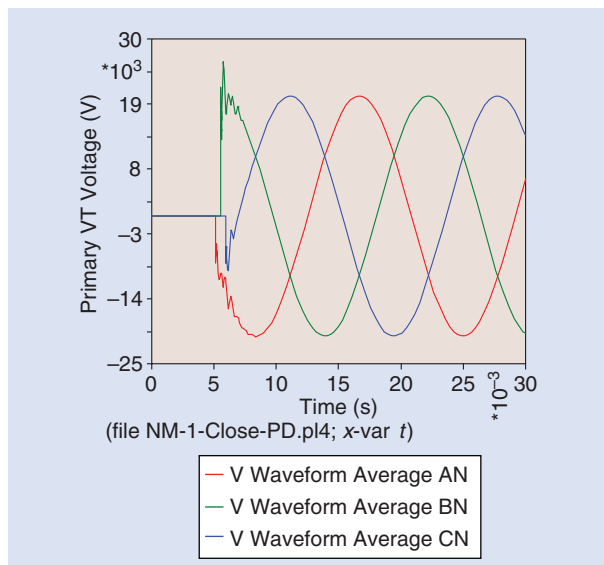
FIGURE 28. The NM-A primary VT voltage after closing the UPM switch (from simulation). AN: phase A to neutral; BN: phase B to neutral; CN: phase C to neutral.

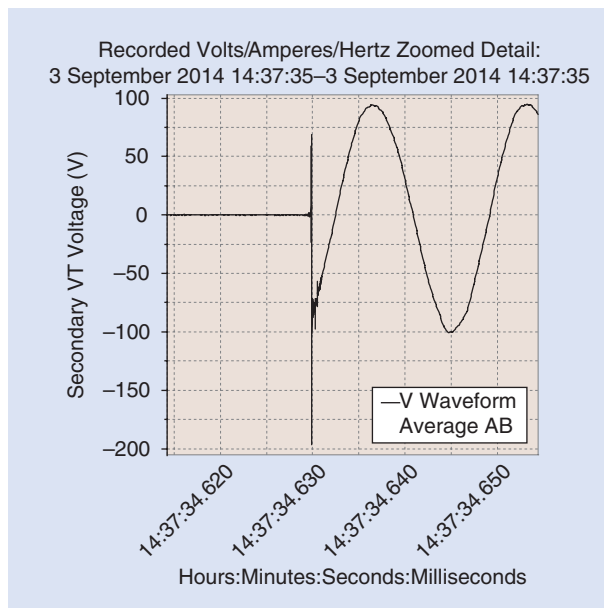
FIGURE 29. The bus VT secondary voltage after UPM switching.

Figures 29 and 30 show the VT secondary voltage when closing the UPM PD-B switch. In Figure 30, notice that phase A closes first, followed by a very small delay when phase B closes, and then a much longer delay until phase C closes. This pole separation or pole disagreement can initiate transients in the other phases for which the pole has not yet opened. In both phases A and B, there is a significant TOV followed by a damped oscillation. The peak as well as the rate of change of voltage can damage the VT primary winding insulation.

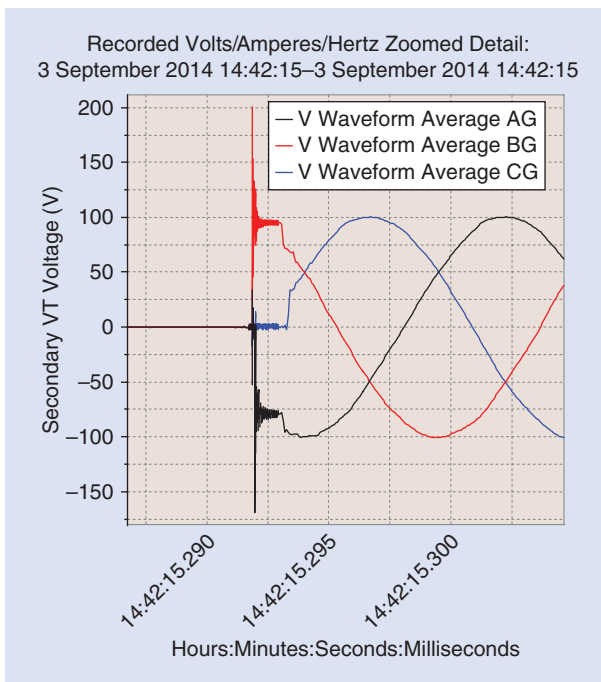
FIGURE 30. The secondary bus voltage after closing the NM-B. AG: phase A to ground; BG: phase B to ground; CG: phase C to ground.

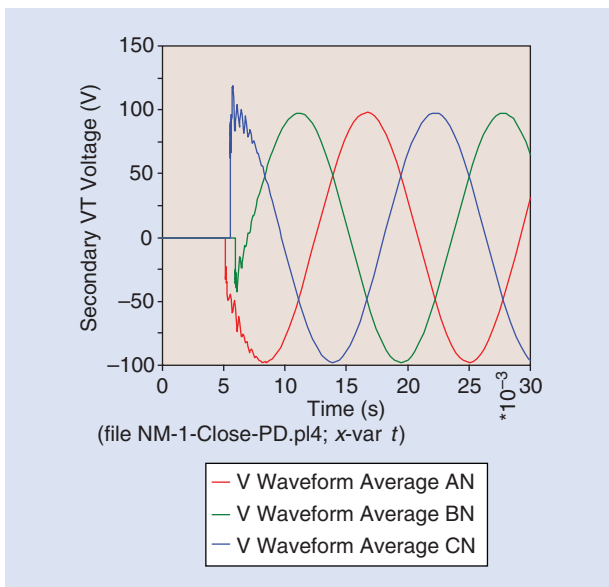
FIGURE 31. The NM-A secondary VT voltage after closing the UPM switch using an off-shelf snubber (from simulation). AN: phase A to neutral; BN: phase B to neutral; CN: phase C to neutral.

frequency of 3,300 Hz, as shown in Figure 31. Note that the case was initially simulated with a 30-Ω resistor and a 0.125 μF capacitor, but repeated using a fine-tuned snubber (100 Ω and 0.25 μF). This analysis shows a reduced TOV of 125.52 V, with a frequency of 2,500 Hz, as shown in Figure 32. There is a reduction in the TOV by using the fine-tuned snubber, but it still damped to an acceptable level.

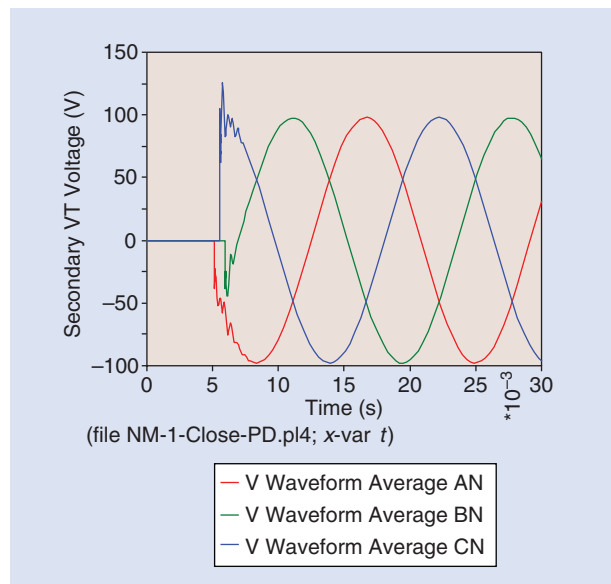
FIGURE 32. The NM-A secondary VT voltage after closing the UPM switch. AN: phase A to neutral; BN: phase B to neutral; CN: phase C to neutral.
