Proactive Study and Novel Mitigation of MV Power System Damage Due to Sub-Power-Frequency Ferro-Resonance for a Gas Plant

Abstract—As projects to expand the processing capacity of a gas plant located in west Texas were pursued, engineering staff observed that the planned incoming medium-voltage power feeder possessed many of the risk factors that have led to increasingly common control-power transformer (CPT) and voltage transformer (VT) failures in industry due to switching. Such failures could involve significant damage and down time. To address these concerns, a computer simulation study was undertaken. As part of initial data gathering, sweep frequency response analysis (SFRA) measurements were performed in an atypical context to establish resonant characteristics of these instrument transformers. When the remote source breaker was modeled to open, connected VTs/CPTs went into severe sub-power-frequency ferro-resonance with probable catastrophic failure. This was verified by Electromagnetic Transients Program (EMTP) simulations as well as by field measurements. The focus of this paper will be on the determination of this unique form of ferro-resonance, identification of risk f

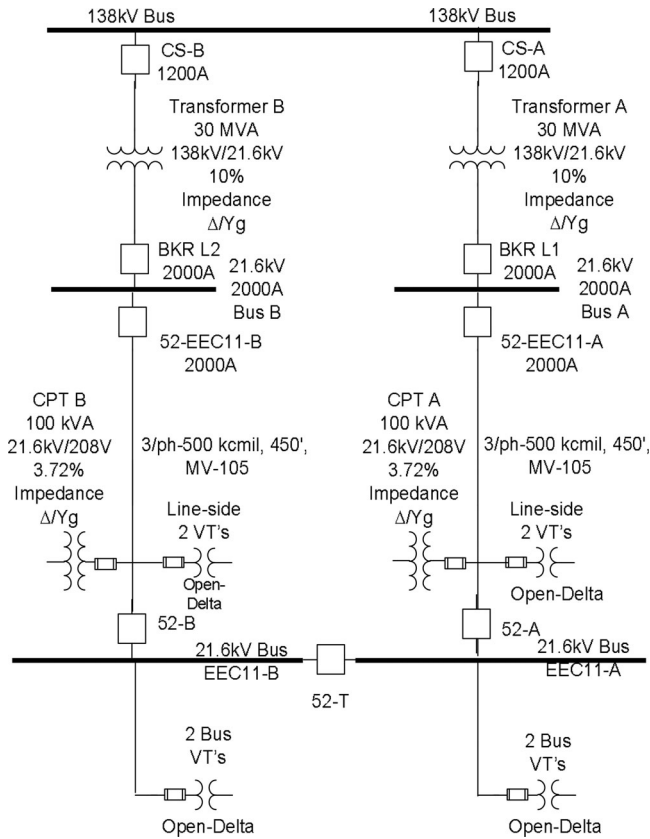
Fig. 1. Simplified one-line diagram for the substation and EEC11 21.6 kV power distribution.

This gas plant facility is supplied by its own substation 138-kV substation bus, which supplies three 30-MVA 138-kV/21.6-kV WYE-connected transformers. This Substation’s three 21.6-kV buses are close coupled to the MV bushings of the 30-MVA transformers. Each 21.6-kV bus is feeding one or two remote switchgear assemblies. The longest cable length from one 21.6-kV bus to a switchgear is 450 ft (feeding switchgear EEC11). The 21.6-kV bus is feeding the switchgears by 25-kV 2000-A general purpose VCBs.

The switchgear EEC11 has two line-side open-delta VTs (VT-A and VT-B) 2000-VA 24 000/120-V 110-kV BIL, two bus open-delta VTs (VT-11N and VT-11S) 2000-VA 24 000/120-V 110-kV BIL and two line-side CPTs (CPT-11A and CPT-11B) 100-kVA 21600:208/120-V 125-kV BIL. The source-side open-delta VT feeds only a relay and a panel voltmeter. The CPT's feed an automatic transfer switch (ATS) that, in turn, feeds auxiliary power (lights, battery charger, A/C, etc.)—or are completely unloaded depending on the position of the ATS. Fig. 1 shows a simplified one-line diagram for this Substation and EEC11 21.6-kV power distribution. Only the equipment that feeds EEC11 are shown, i.e., two of the three 30-MVA transformers and two of the three 21.6-kV busses.

In Fig. 1, BKR 52-EEC11-A (see Fig. 1) was opened. Figs. 2 and 3 represent the simulation results. The VTs severely saturate and the 20 Hz form of ferro-resonance occurs. The actual frequency settles out at near 14 Hz. Fig. 3 better illustrates this. Because there is no significant load connected at each VT secondary, very little damping occurs; which indicates the ferro-resonance persisted for the duration of the simulation time. The y-axis is voltage, and the x-axis is time in seconds for all graphs.

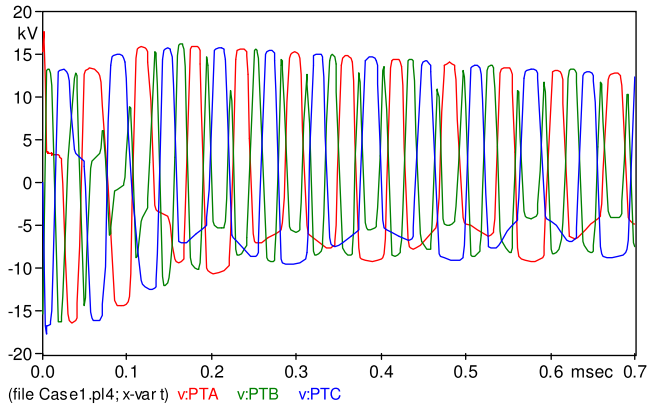
Fig. 2. Primary line-to-ground voltage after breaker opens; illustrates Ferro-resonance.

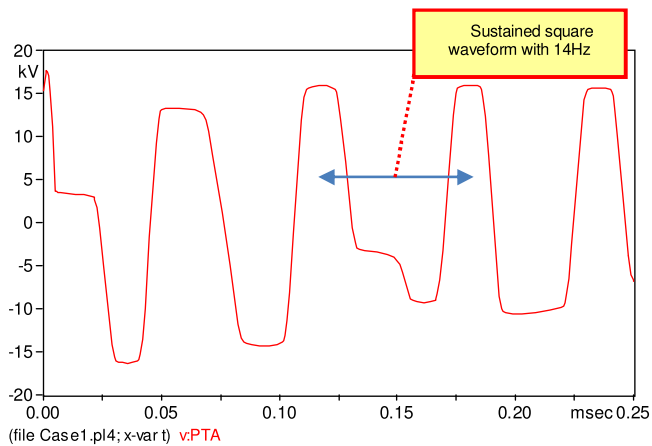
Fig. 3. Phase B line-to-ground from Fig. 2.

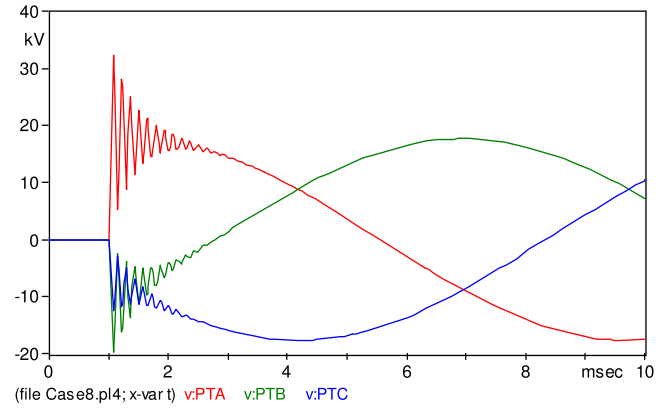
Fig. 4. Line-to-ground voltage after switch is closed; no Snubber.

Fig. 4 represents closing the BKR 52-EEC11-A in Fig. 1. It was noted that the VTs and the CPT were going to require resistive loading to mitigate ferro-resonance. Therefore,

the VTs were simulated with 500-W space heater loading (see Section VI) with the hope that the resistive loading would be enough to mitigate the switching transient overvoltage condition. Fig. 4 shows EEC11 line-to-ground voltage. The transient overvoltage (TOV) is 32.17 kV with a frequency of 6500 Hz. Although the voltage magnitude of the TOV is within the VT BIL of 125 kV, the TOV frequency is above the recommended frequency of 1000 Hz (equivalent dv/dt consideration of the transformer winding). A snubber is recommended at this location to reduce TOV frequency.

In Fig. 16, the prestrike/reignition closing transient shows dramatic reduction and almost complete elimination of the ring wave as predicted in Fig. 4 (see arrow). Note how closely it matches the simulated wave form in Fig. 9. This shows very good snubber action as well.

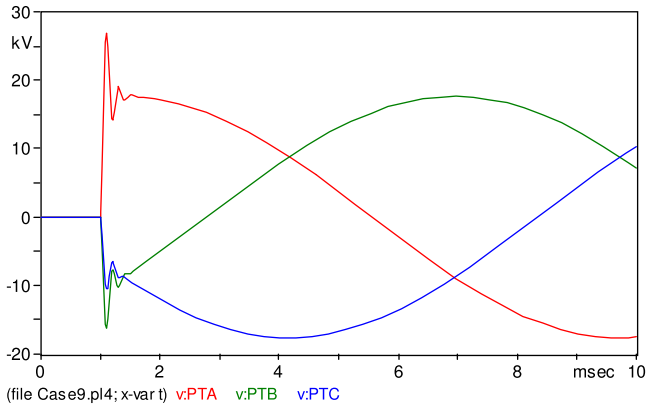
Fig. 9. Line-to-Ground Voltage After Switch is Closed; with custom snubber.

Fig. 9 shows the line-to-ground voltage with snubbers (compare to Fig. 4). The TOV is 26.84 kV with an overdamped frequency response. The snubber circuit is recommended for this location as it will alleviate the possibility of transformer internal resonance during the closing of the VCB and lowers the natural frequency to well under 1000 Hz.

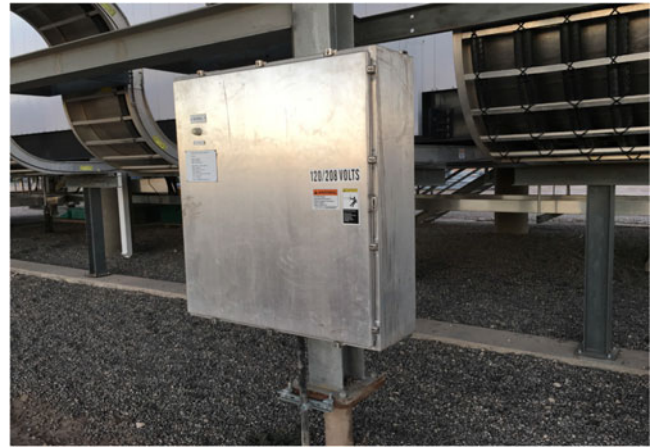
Fig. 10. CPT switched resistor control cabinet.

breaker was switched open. It was also decided that running control wiring between substations was a solution of last choice. Note that an underfrequency relay (81U) is indicated in Fig. 8 and housed in a control cabinet of Fig. 10. The novel approach here was to sense frequency at the CPT as the ferro-resonance condition quickly decays to 14 Hz. An 81U relay was selected over other types of relays because frequency is unique to this ferro-resonance condition where all other available electrical parameters could be caused by multiple phenomenon and could result in nuisance operations. The 81U relay was set to cause the resistive load contactor to close any time the frequency decayed to less than 50 Hz and open about 10 s later. The 10 s active time for the resistive load is more than adequate because the resistive load provides damping in 200 ms. Other controls assured excessive cycling did not occur (not shown). In this manner, control wiring between substations was not required—along with all the related concerns being eliminated.

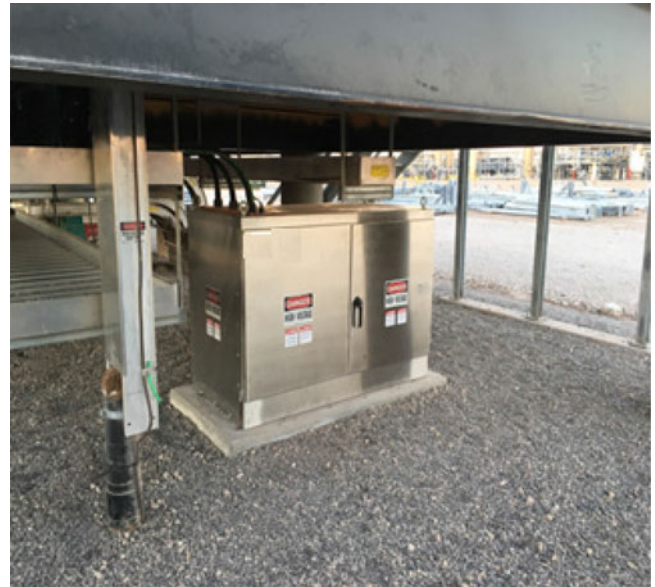
Fig. 13. Completed snubber installation at EEC-11.

The completed snubber installation is shown in Fig. 13. The dimensions of the enclosure are 48 in H × 36 in D × 72 in L. The front-doors and removable side panel are visible on the NEMA412 stainless steel enclosure. Notice the gradual bend in the 4/0 AWG phase and ground cables as they exit the snubber and enter the cable tray, which is the minimum bending radius of this 4/0 cable. The supplemental ground of the enclosure to the ground grid is visible at the lower left corner of the enclosure.

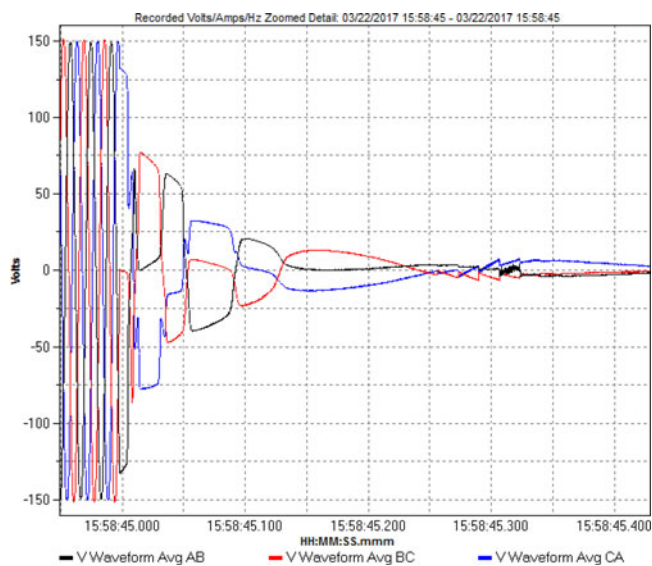
Fig. 15. VT opening measurements.

In Fig. 15, the VT secondary voltages are shown. The 20-Hz ferro-resonance condition is quickly damped out. The VTs have fixed space heaters connected all the time. Compare Figs. 14 and 15 with Fig. 6. The measurements confirm the presence of 20-Hz ferro-resonance and how effective the damping resistors

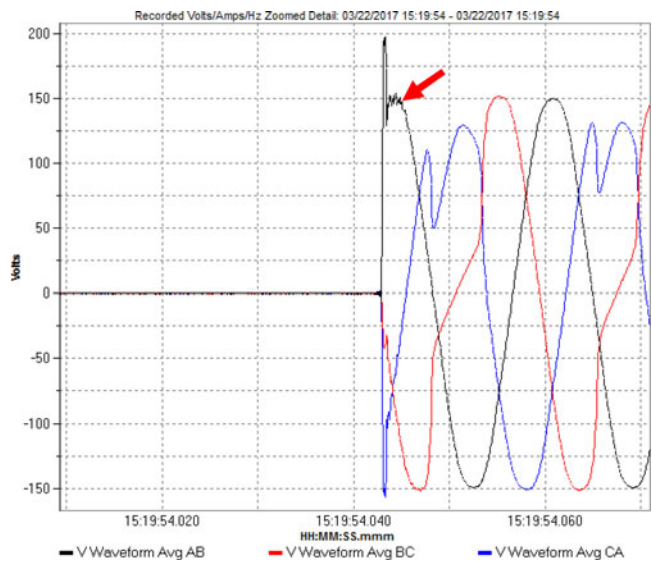
Fig. 16. CPT energization measurements.
