# Benchmark tests of factory production and third-party reconditioned mining circuit breakers

This paper examines the quality, safety, and reliability of a random sample of 12 reconditioned circuit breakers resold and refurbished by third parties for mining applications ①. Improper modifications to circuit breakers could lead to application failure, unsafe conditions, unreliable operation, or personal injury. This paper contrasts test results of the 12 refurbished breakers with newly manufactured Eaton molded-case circuit breakers. When breakers fail to perform to specifications, there is an increased possibility of application failure and unsafe conditions for personnel.

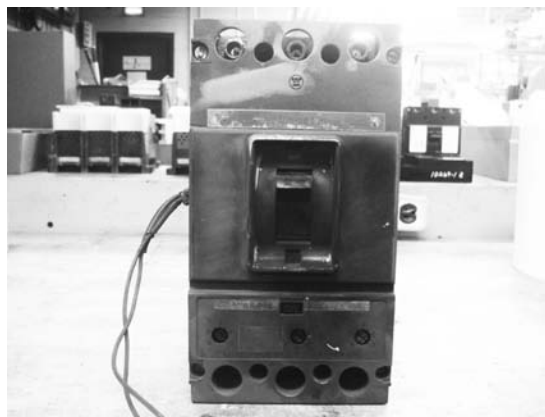
An HKA labeled third-party breaker was tested and compared to a new Eaton circuit breaker. The third-party breaker failed to trip on time in pre-test calibration, and then received its first high-level fault-interrupting test, which resulted in the center pole cable pulling out of the breaker, and the cover separating from the base (see **Figure 1** and **Figure 2**). The test breaker failed to interrupt the fault in time, so the laboratory backup breaker had to clear the circuit. The refurbished breaker was unable to attempt a second interruption. Eaton's new breaker received both high-current faults and is in notably better condition post-interruption (**Figure 3**) than the sample third-party modified breaker, pictured in **Figure 1** and **Figure 2**.

**Figure 1. HKA Breaker Repaired by Third-Party Refurbisher, Following Testing**

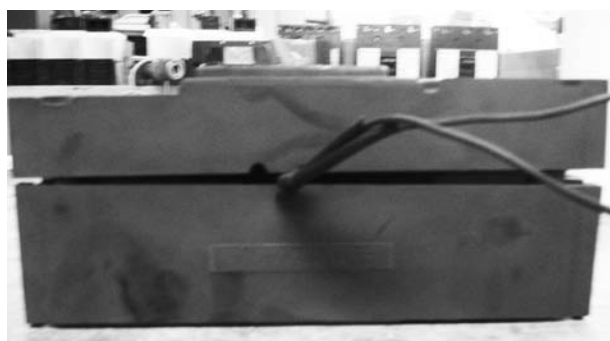
**Figure 2. Breaker Cover Separated from Base During High Fault Test**

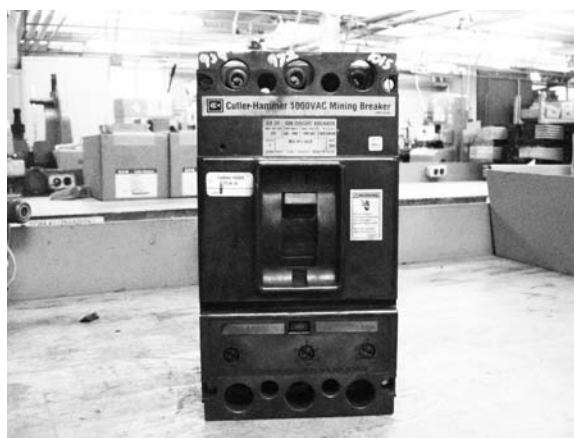
**Figure 3. Eaton Manufactured Mining Breaker with Proper Identification and Labeling; Successfully Passed Testing Sequence**

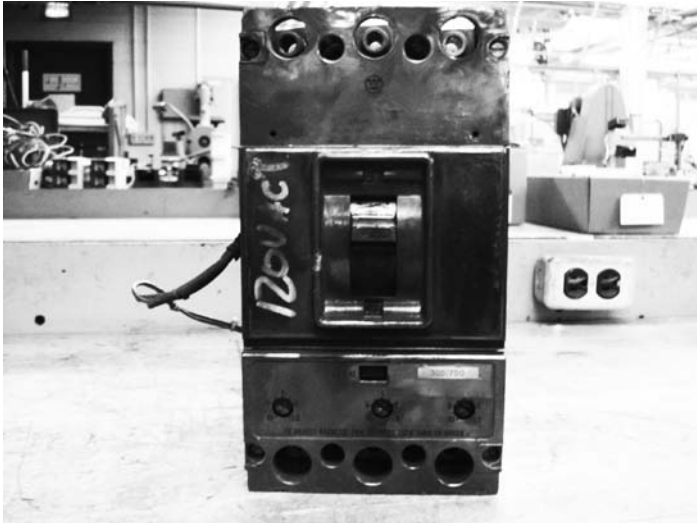
A similar looking breaker from a third party was tested. This breaker appeared like Eaton's HKA; however, it had no nameplate or catalog information to properly identify it or its ratings. The breaker's ratings were assumed to be those of the Eaton HKA design, and it was subjected to the high interruption test. When the breaker was first closed, there was no continuity in the center and right poles, which prevented it from being calibrated. It failed the first high fault interrupting test, with the cover separating from the base, and the laboratory backup breaker cleared the fault (see **Figure 4** and **Figure 5**). The sample third-party breaker is in worse condition than the comparable newly manufactured Eaton breaker after the same test (**Figure 3**).

**Figure 4. Third-Party Refurbished Breaker Without Nameplate or Product Identification**

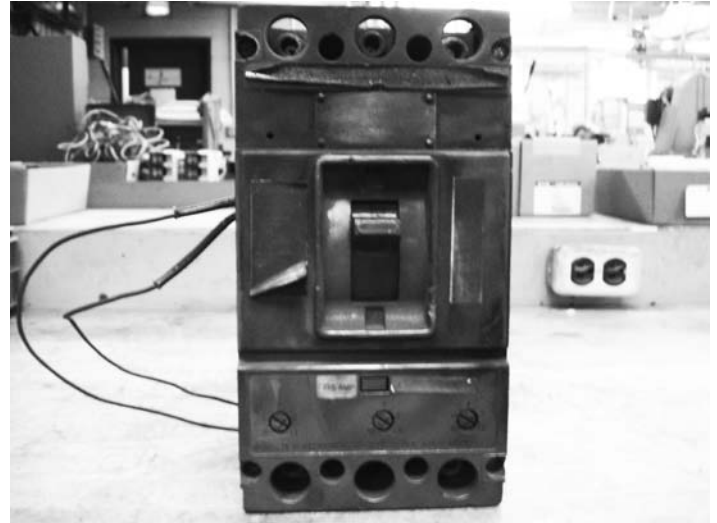
Another sample modified breaker, type HKA, was tested in the high interruption test at 480V, 60 Hz, with 35,000A available. The third-party sample failed the first high fault interruption test, with the base separating from the cover and the lab back-up breaker clearing the fault. The wires were pulled out of the left and center poles. The third-party sample is again in much worse condition than the new Eaton sample, even after the Eaton breaker endured a second fault interruption test. **Figure 6** shows the third-party unit after testing, and **Figure 7** shows that the A and C phase line conductors (on top) overheated and the material melted off.

**Figure 6. Third-Party Refurbished Breaker Shown Post-Testing; No Nameplate Provided**

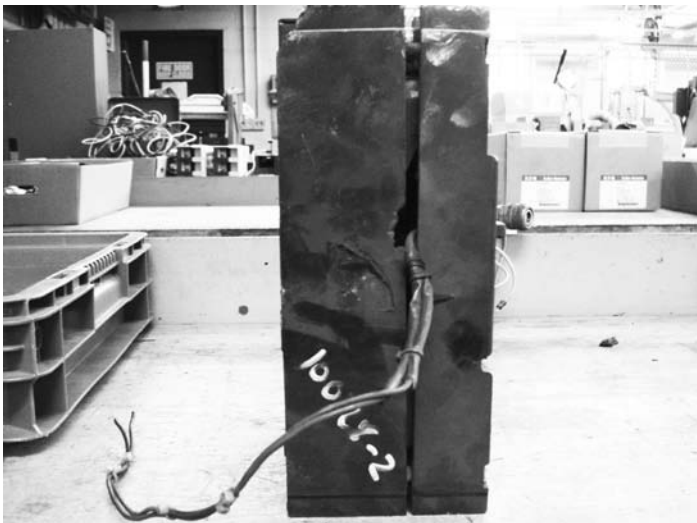
**Figure 5. Post High Fault Test; Breaker with Cover Separate from Base**

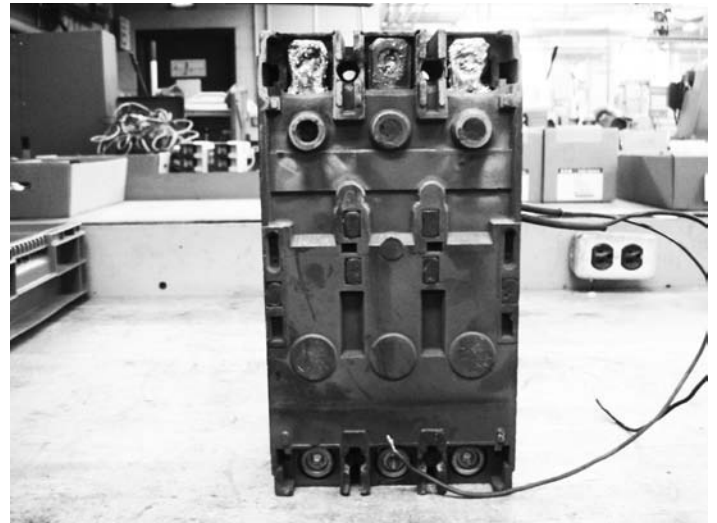
**Figure 7. Breaker After High Fault Test; Conductor Material Overheated and Melted Away**

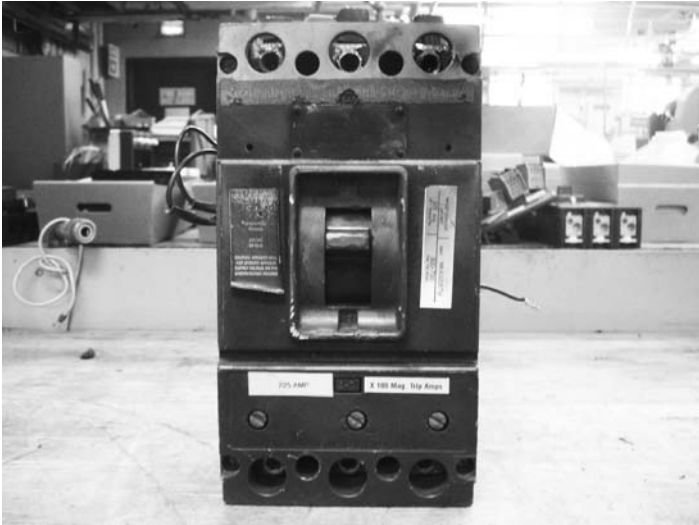
Another HKA third-party reworked breaker was subjected to a low-level short-circuit test. The third-party sample passed pre-test calibration, but it failed to interrupt in the first short-circuit test and allowed an arc to strike the test enclosure. The ground fuse connected to the enclosure was opened by the excess current of the arc to ground, and the wires welded to the terminals. In addition to failing to interrupt, the opening of the ground fuse is also a non-conformance. **Figure 8** and **Figure 9** show the unit after testing.

**Figure 8. Third-Party Refurbished Breaker Failed to Interrupt on Short-Circuit Test**

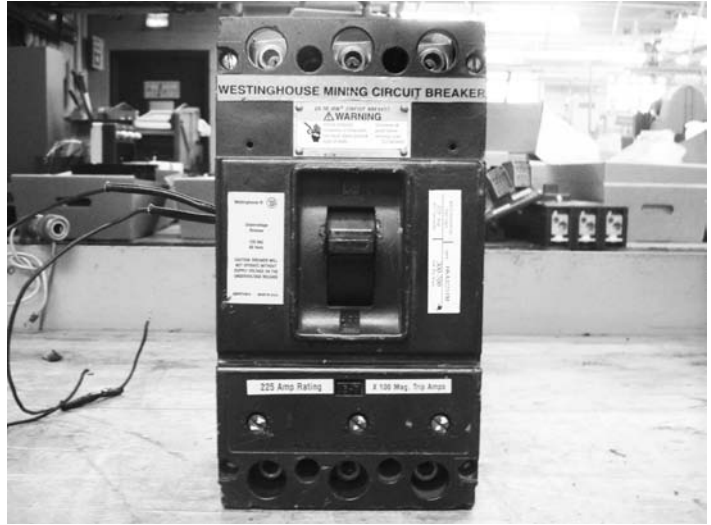
The unit was believed to be an HKA; the sample was tested for endurance based on Eaton's published data for the HKA frame. The third-party sample passed initial calibration, but failed the endurance test when the ground fuse opened during the load operations at the rated current. After the ground fuse opened, the center pole of the breaker did not have continuity when closed. **Figure 10** and **Figure 11** depict the third-party breaker after testing.

**Figure 10. Third-Party Refurbished Breaker After Failing Load Endurance Test**

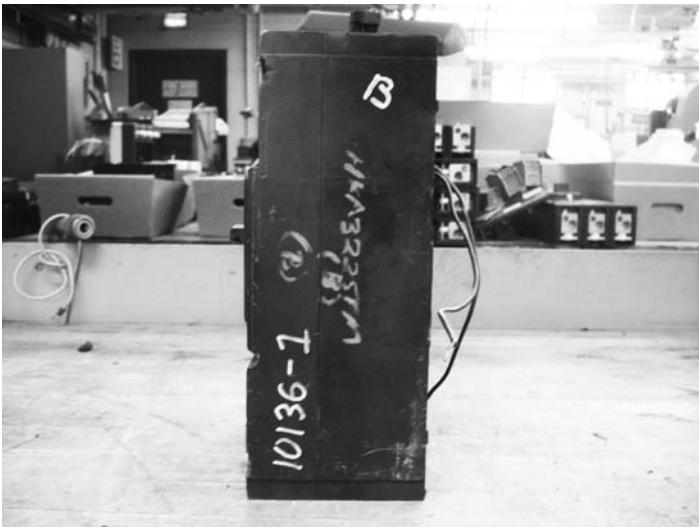
**Figure 9. Wires Welded to Terminals After Excess Current Traveled to the Ground**

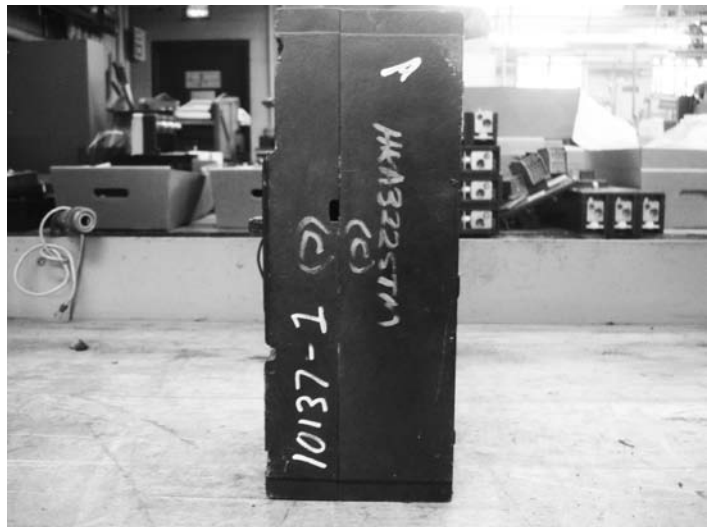
**Figure 11. After Failure, Breaker Lost Continuity in the Center Pole**

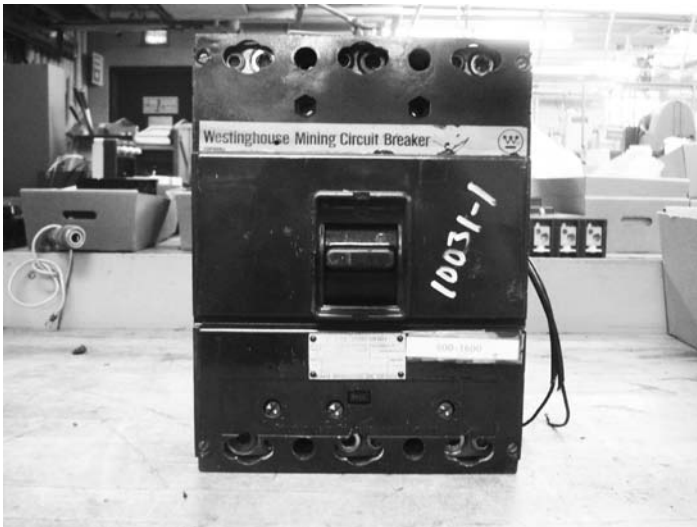
In this test, the third-party unit appeared similar to Eaton's LAM circuit breaker, but the nameplate had limited information. It was tested in accordance with the calibration test procedures. The third-party breaker tripped below the maximum time limits in 200% single-pole and 135% three-pole initial calibration tests and passed the overload portion, but it failed to remain closed during the temperature rise test at 100% of rated current. The breaker tripped before its temperature stabilized. The results indicated that the thermal release on the third-party sample was not properly calibrated; the error was likely to result in nuisance tripping. Eaton's production test procedures require trip units to be calibrated so that breakers will not trip before temperatures are stabilized at 100% of the rated current in their designated ambient temperature. **Figure 12** and **Figure 13** are photographs of the failed refurbished breaker after the test.

**Figure 12. Third-Party Refurbished Mining Breaker with Limited Nameplate Information**

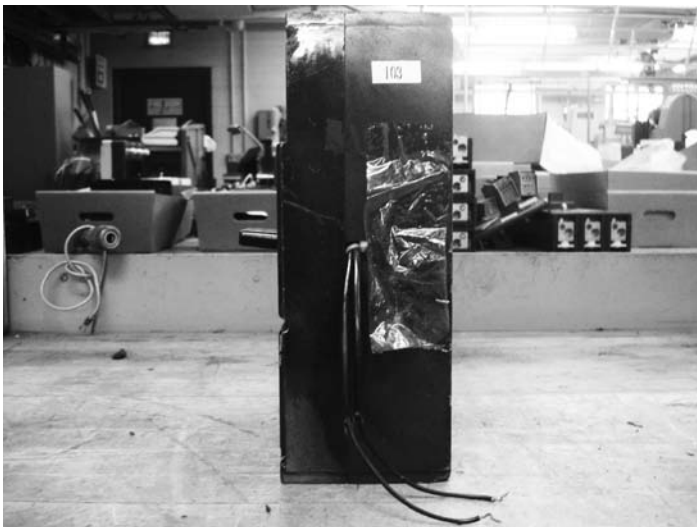
**Figure 13. Breaker Did Not Stay Closed During Temperature Testing, Indicating Incorrect Calibration**

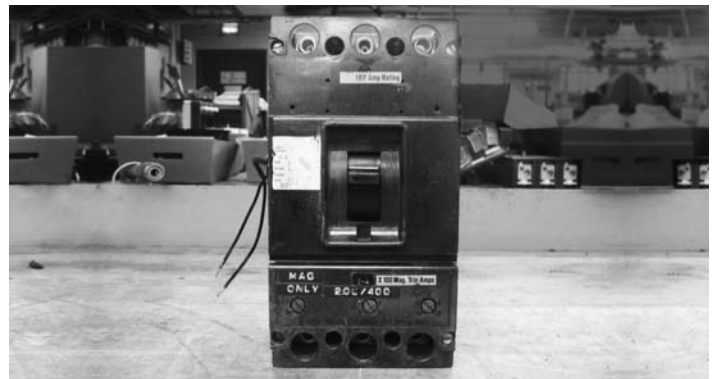
A sample third-party modified HKAM breaker was subject to the endurance testing and compared to an Eaton HKAM circuit breaker from current production. The third-party refurbished breaker had a malfunctioning undervoltage release (UVR) that would not stay engaged with the full rated 120V applied to it. Consequently, it would not remain latched and the breaker could not be closed; **Figure 14** and **Figure 15** are photographs of the third-party breaker after testing. In contrast, the Eaton newly manufactured breaker passed every portion of the testing procedure, which includes pre-calibration, endurance operations, a low-level interruption, post-calibration, and dielectric withstand. **Figure 16** is an image of the Eaton production breaker after testing. Eaton tests the pickup and dropout voltage of each UVR to ensure that the accessory functions properly when installed in the circuit breaker.

**Figure 14. HKAM Mining Breaker Modified by Third-Party Refurbisher**

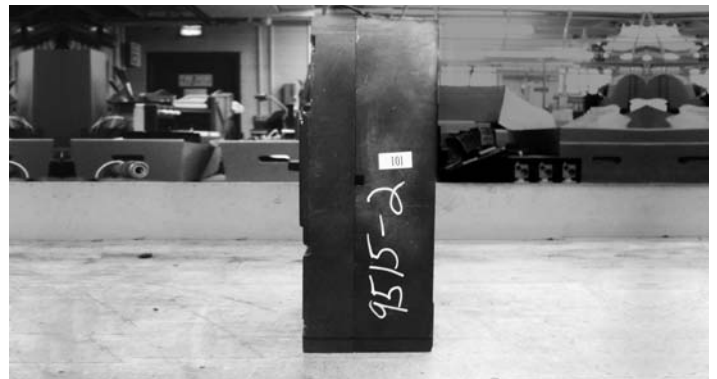
**Figure 15. Undervoltage Release Accessory Malfunctioned; Breaker Could Not be Reclosed**

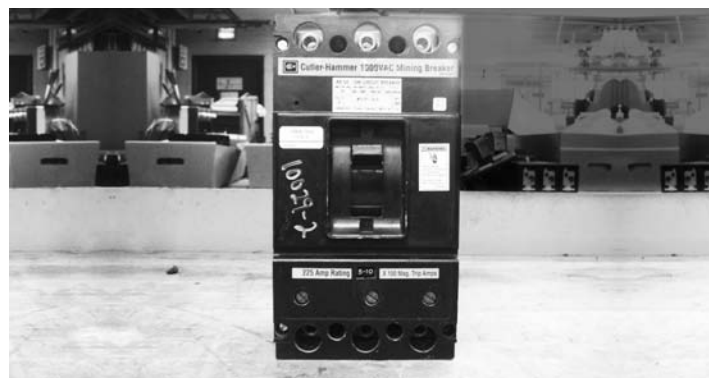
**Figure 16. Eaton Manufactured Breaker; Undervoltage Release is Tested for Proper Operation**

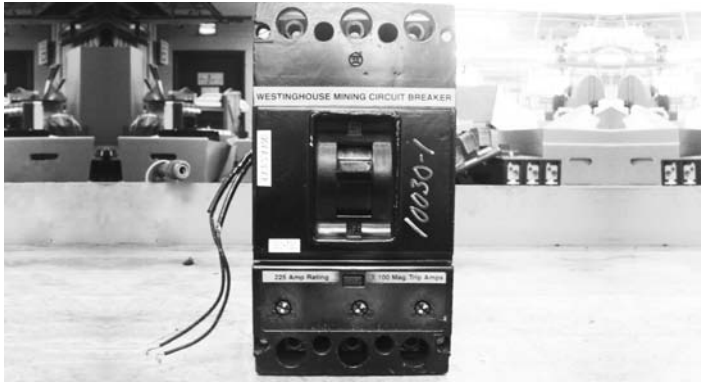
The third-party breaker had incomplete information on homemade labels. The sample was tested for low-level interruption and compared to a new Eaton HKAM circuit breaker from current production. The third-party breaker failed initial calibration, with one pole carrying 200% of rated current past the allowable trip time. The sample completed the short-circuit portion of the test and passed post-interruption dielectric withstand. Eaton's circuit breaker passed the sequence with no non-conformances.

**Figure 17. Third-Party Refurbished HKA Breaker with Poor Quality, Homemade Labels; the Breaker Failed to Trip on Overload Test**

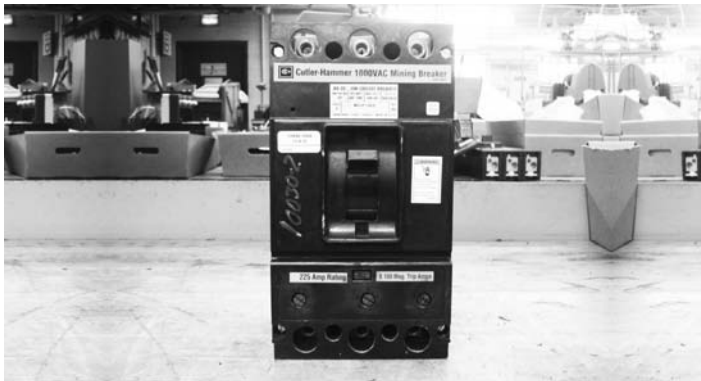
**Figure 18. Eaton Production Breaker Shown After Testing; it Passed the Entire Test Sequence with No Issues**
