Partial Vacuum Flashover Phenomenon

**November 1997
Insulated Conductor Committee
Presentation**

*LOW CURRENT
SWITCHING
PHENOMENA*

By: John M. Makal
Staff Engineer
Nov. 3, 1997
ICC Project 10-46

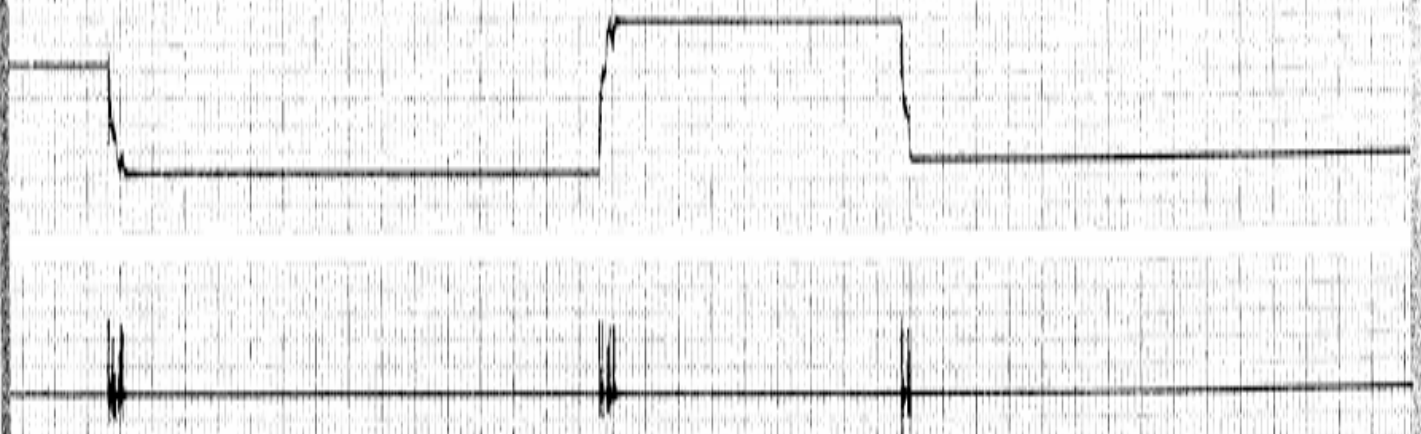
Cable
Bushing

32 kV peak

Cable voltage 2 division = 1 p.u.

Time Base = 100.0000 us/div

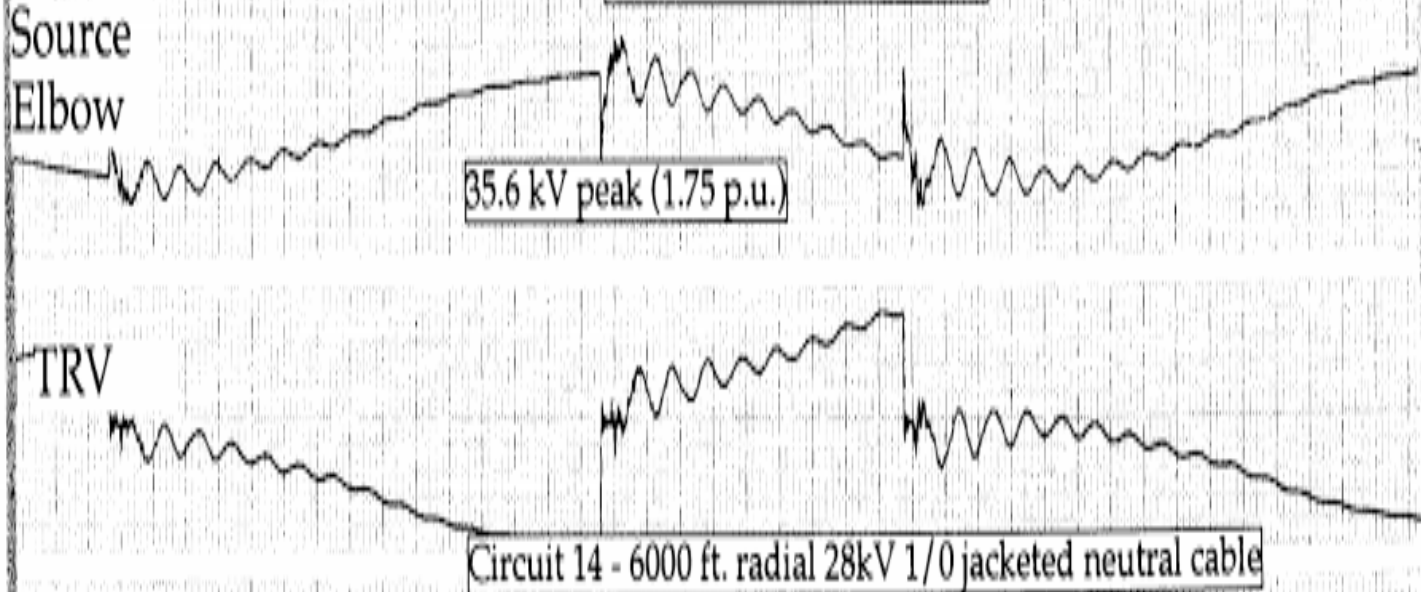
25kV Cable switching

Circuit 14 Test 21 - 4/21/94
Shot 127 Elbow Break
14.4 L-G

Source
Elbow

35.6 kV peak (1.75 p.u.)

TRV

Circuit 14 - 6000 ft. radial 28kV 1/0 jacketed neutral cable

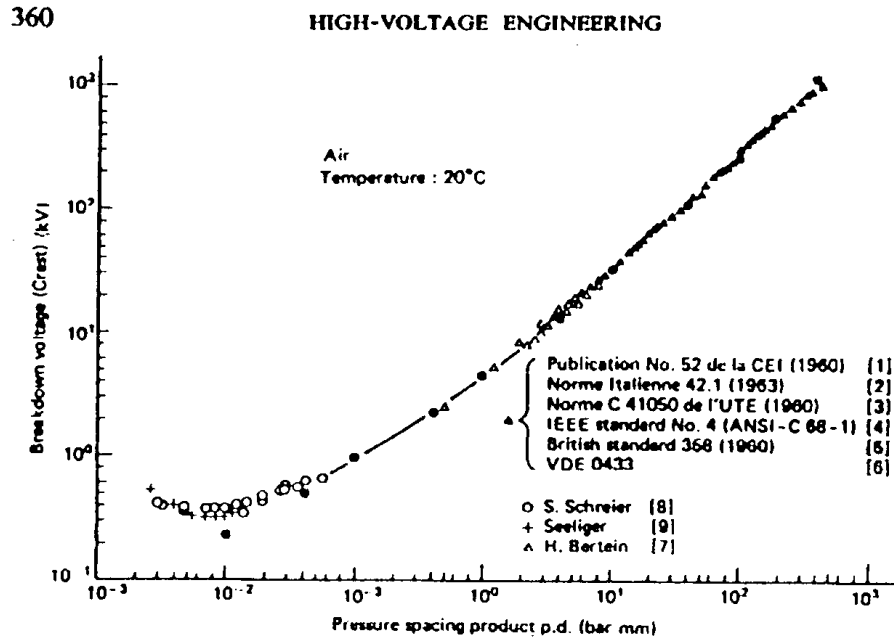
Paschen's Curve

FIG. 5.23. Paschen curve for air in log-log scale. Temperature 20°C. (● calculated $V_b = 6.72\sqrt{pd} + 24.4(pd)$).^(7,4) Note formula in bar-cm

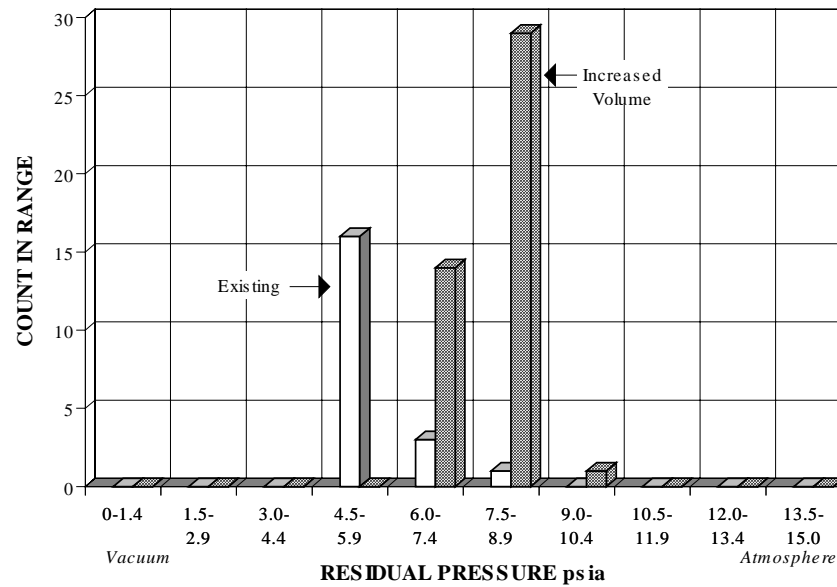
MINIMUM INTERNAL PRESSURE DURING REMOVAL OPERATION

Existing vs. Increased Volume Cap ('97 data)

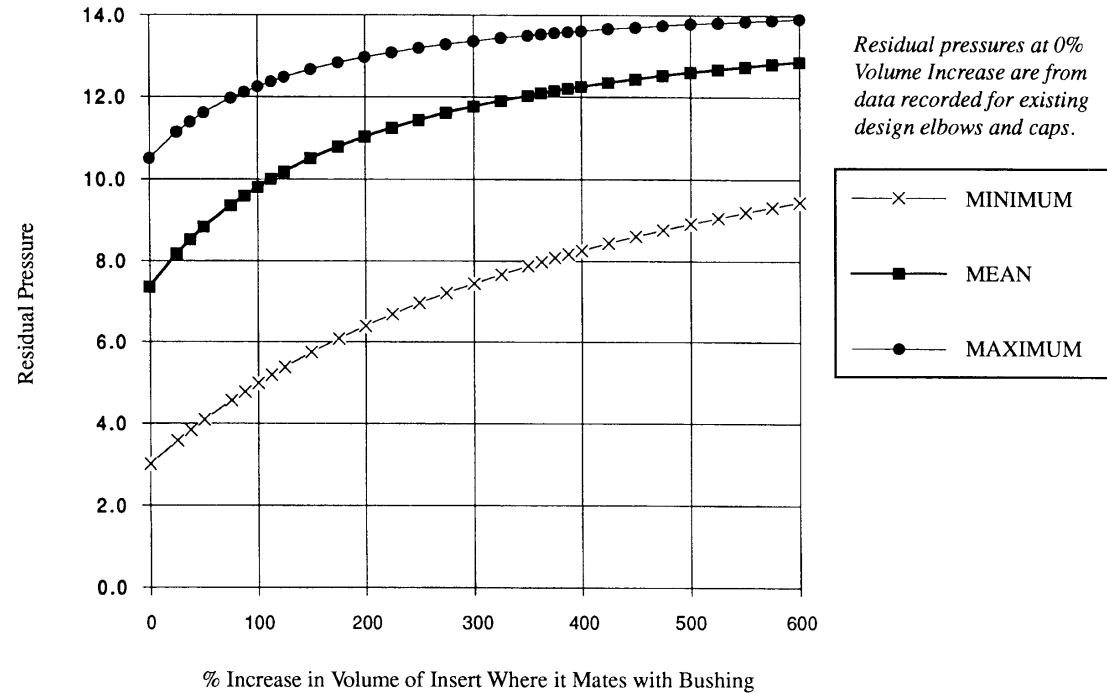
INCREASED VOLUME INSERT DESIGN

Residual Pressure vs. Increase in Volume of Insert

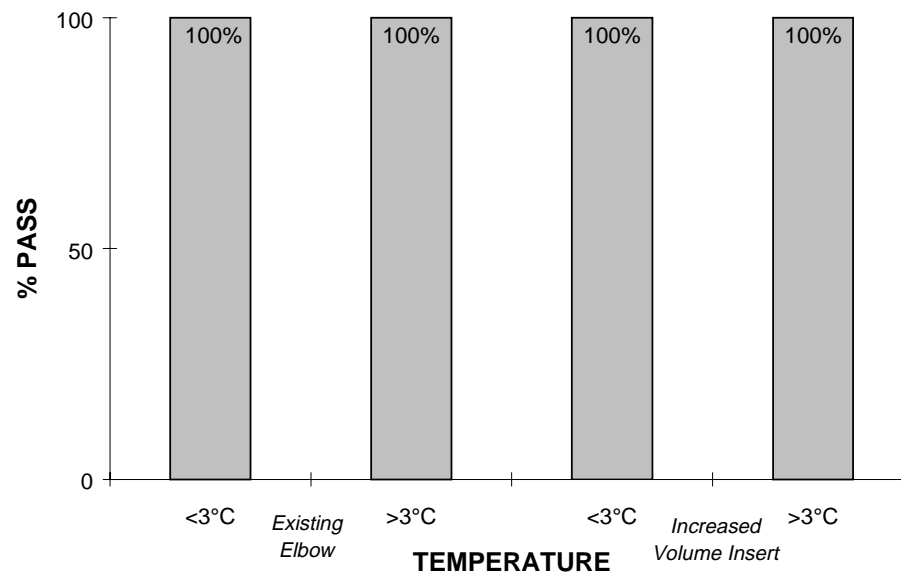
*Switching Success Rate
vs. Design and Temperature
(14.4 kV)*

LOW CURRENT SWITCHING RESULTS				
Test Voltage Line-to-Ground kV	Test Temperature °F/°C	Tested	Pass	% Pass
14.4	<3	49	49	100
14.4	>3	52	52	100
27.5	-20	24	14	58
27.5	+20	12	12	100

LOW CURRENT SWITCHING RESULTS				
Test Voltage Line-to-Ground kV	Test Temperature °F/°C	Tested	Pass	% Pass
14.4	<3	95	95	100
14.4	>3	57	57	100
27.5	-20	21	10	48

LOW CURRENT SWITCHING RESULTS				
Test Voltage Line-to-Ground kV	Test Temperature °F/°C	Tested	Pass	% Pass
27.5	-20	20	20	100
27.5	+20	12	12	100
