Customer Success Story: The Linde Group

Eaton's InsulGard mitigates unexpected motor failure risk and improves production uptime for The Linde Group's facilities

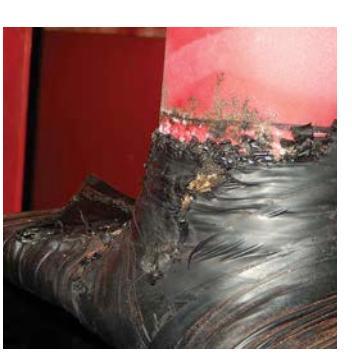
Insulation deterioration within the terminal box motor CP11.

In May 2015, Eaton flagged an MV motor showing elevated activity on the InsulGard monitor during routine remote monitoring. Both the Linde regional electrical engineer and Eaton reviewed the data and together they concluded that the activity was occurring in the motor termination box.

A planned outage was scheduled for June to investigate the activity; however, it had to be postponed until December. Eaton PD engineers were continually consulted during the extended period. During the outage, the motor termination box was opened and evidence of PD as well as tracking was confirmed.

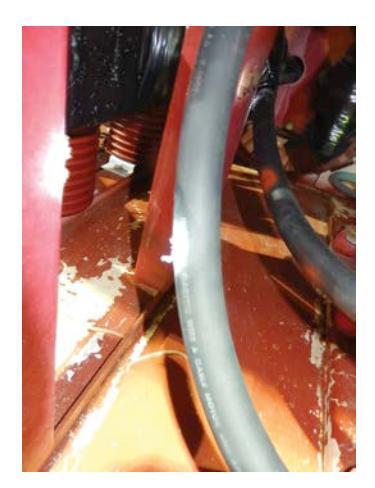
Findings affecting the termination compartment.
