## Eaton capacitors dielectric performance under dc voltage stress

© 2017 Eaton  
All Rights Reserved  
Printed in USA  
Publication No. WP230001EN / Z19355  
March 2017

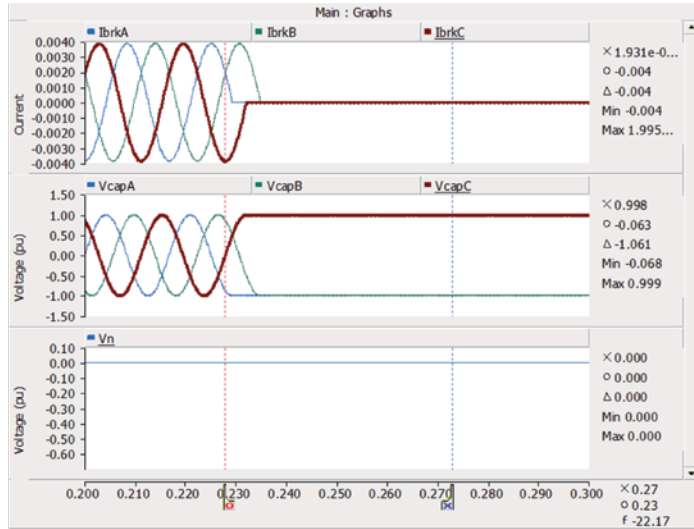
**Figure 1** shows the current and voltage oscillograms upon de-energization of a grounded-wye capacitor bank. The trip command is shown as the dashed, red vertical line. The current traces show how each phase current is interrupted at the first zero current crossing immediately after the trip command. This occurs even with gang-operated switching devices. The trapped voltage for each phase is shown as a positive or negative peak value (1 pu) at the time the corresponding phase current is interrupted.

Figure 1. Current and voltage traces during de-energization of a grounded-wye capacitor bank

De-energizing a capacitor bank always results in a trapped dc voltage in the capacitor as the current interruption always occurs at a current zero and, given the 90-degree phase angle relationship between voltage and current through a capacitor, the trapped voltage is always at peak value. The trapped dc voltage upon de-energization of a grounded-wye capacitor bank is the peak value of the system line-to-ground rms voltage or  $\sqrt{2} \times V_{\text{sys}}$  (that is, 1 pu).

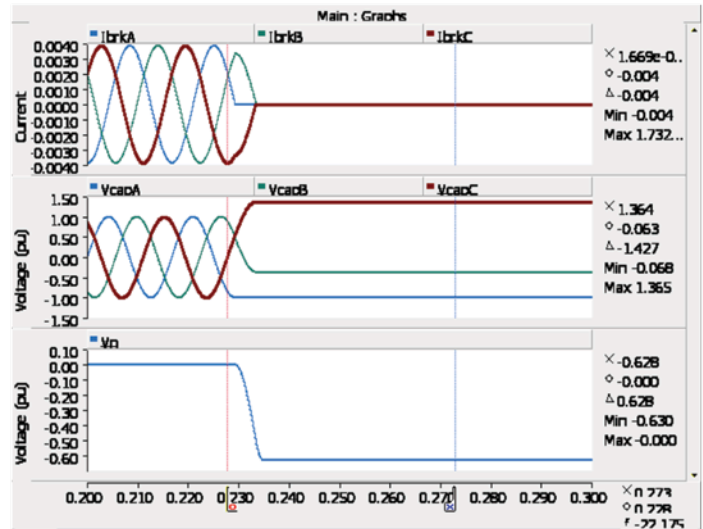
Figure 2. Current and voltage traces during de-energization of an ungrounded-wye capacitor bank

Figure 2 shows the current and voltage oscillograms upon de-energization of an ungrounded-wye capacitor bank. Again, the trip command is shown as the dashed, red vertical line. The phase currents are interrupted at the first zero current crossing immediately after the trip command with phase A being the first to be interrupted. At the next current zero, both B and C phase currents are interrupted as the capacitors in these two phases are now connected in series with line-to-line voltage applied across the two capacitors (Figure 3). The bottom trace shows the neutral voltage and how it shifts with respect to ground after the phase A current is interrupted, causing the voltage on the phase C capacitor to reach a peak value of 1.36 pu at the time its current is interrupted. This is the trapped dc voltage level on this capacitor and will decay slowly due to the discharge resistor connected between the capacitor terminals.

The trapped dc voltage upon de-energization of an ungrounded-wye capacitor bank depends on the neutral voltage at the time of interruption. The trapped voltage in the capacitor on the first phase to interrupt the current is + or - 1 pu. The magnitudes of the trapped voltages on the capacitors on the other two phases depend on when their current is interrupted. It can be much higher than 1 pu.

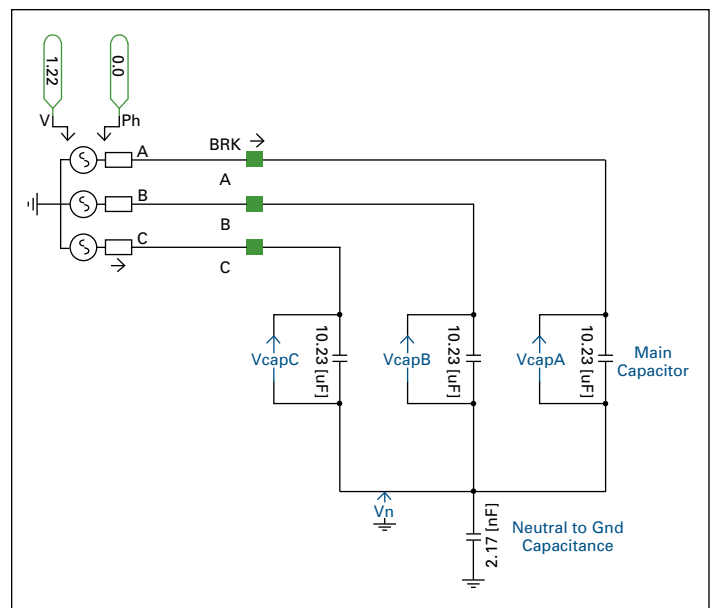
Figure 3. Ungrounded-wye capacitor bank schematic circuit

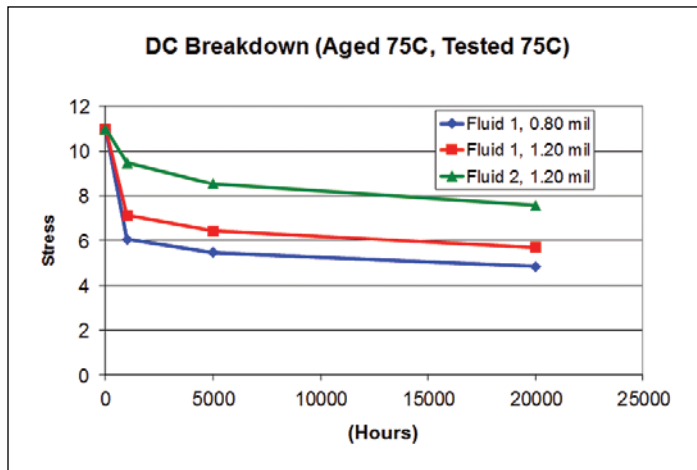
**Figure 4** shows how the dc withstand of all-film capacitors and how the dc withstand level is significantly reduced during the first 1000 hours of operation at system voltage. The figure also shows how the dc stress withstand is impacted by the properties of the dielectric fluid and the dielectric pad thickness. The dc voltage stress withstand is further reduced at high-operating temperatures.

**Figure 4. dc stress withstand of an all-film capacitor dielectric system**

As a result of the investigation, Eaton formulated a dielectric fluid with superior high-temperature dc and discharge inception voltage (DIV) performance, the Edisol® VI dielectric fluid, and uses it on all capacitor units they manufacture. In addition, the design rules were modified to limit the minimum thickness of the dielectric system used in Eaton's capacitors. The dc performance of the Eaton design with the Edisol VI dielectric fluid is shown in **Figure 4** (Fluid 2, green graph).
